Earthwise Society Wetland Restoration Construction Report 2019

CREATED FOR ENVIRONMENT AND CLIMATE CHANGE CANADA

Natasha Wilbrink
FRASER VALLEY CONSERVANCY | #2-7331 JAMES ST. MISSION

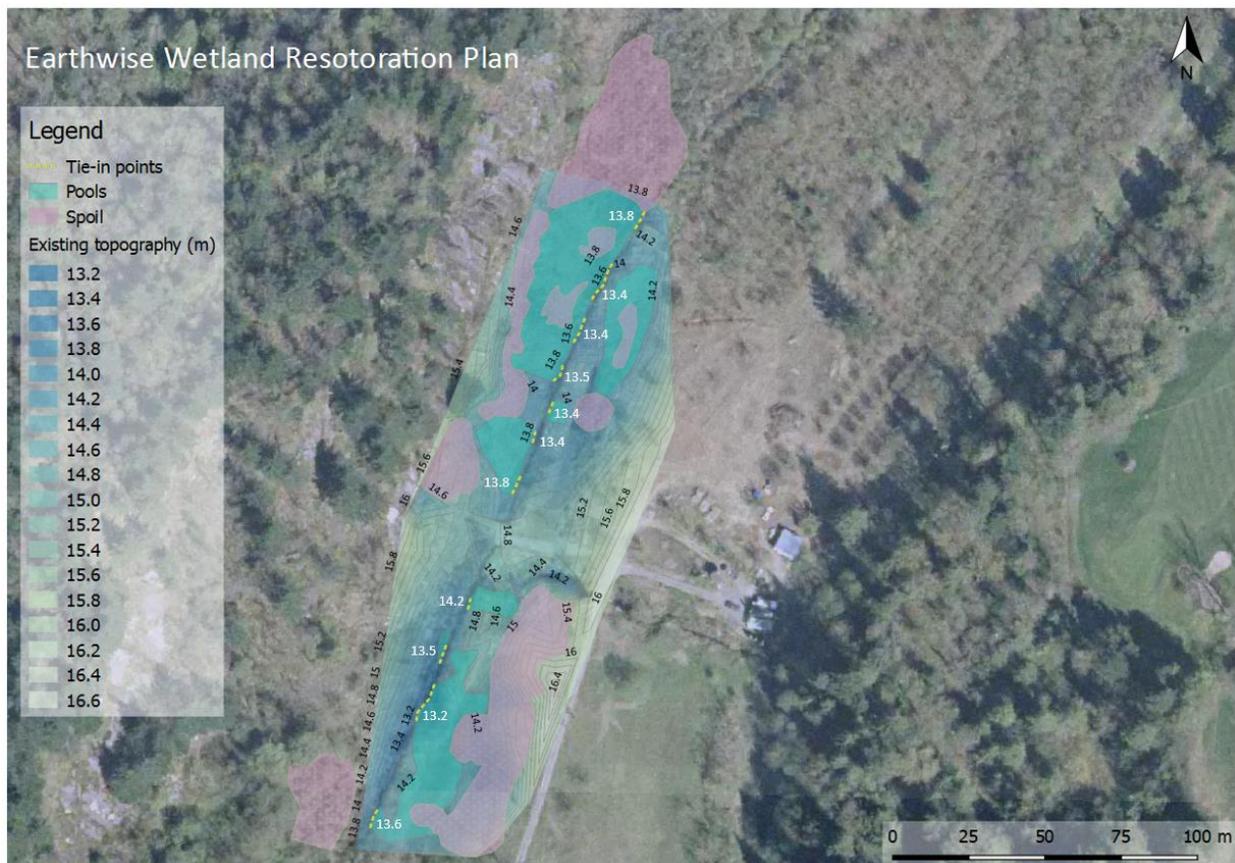
Figure 2: Design plan for wetland restoration including tie-in points to existing waterway, location of pools and location of spoil overlain on existing topography of the site. White text indicates elevation of tie-in point.

Specifically, we maintained the integrity of the hardhack islands and other large woody debris in order to limit damage to PWS habitat. We added additional large woody debris to the pools we created to further enhance habitat for PWS and provide corridors for movement. In order to manage for Salish Sucker, we strategically designed the pools to be deepest at the tie-in points and become shallower as they move away from the stream. This allows fish passage as water level recede and ensure that fish stranding does not occur. All pond depths were therefore, dictated by the depth of the stream at their tie-in points.

The southern-most pool was designed to target OSF oviposition. Pre-construction conditions were such that this pool was exposed to the greatest amount of solar radiation as it is open with seven larger non-native walnut trees offering some shading from the east. Existing vegetation in this area was Reed canarygrass. In contrast, the other pools were designed to exist in the context of the vegetation that was present on the landscape prior to construction works. These areas were dominated Hardhack and willows. Plantings supplemented pre-existing vegetation with additional shrubs and trees. Long-term goals are to remove these non-native trees as native stock grows in such a way as to not lose critical shading while simultaneously increasing the diversity of the wetland.

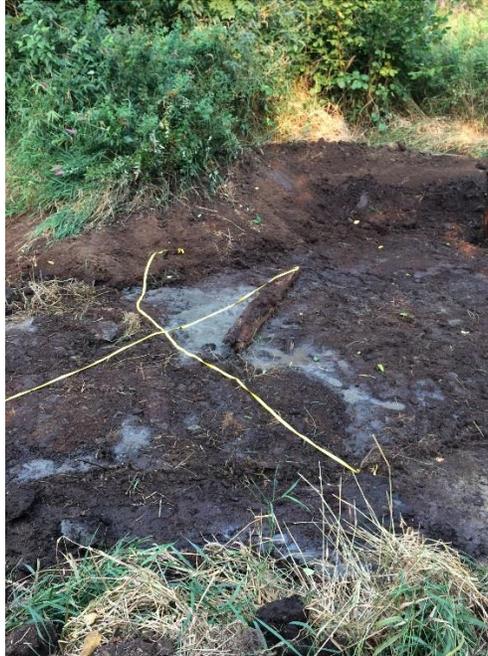
Figure 3: Safety hazards were marked for easy identification by project staff and contractors.

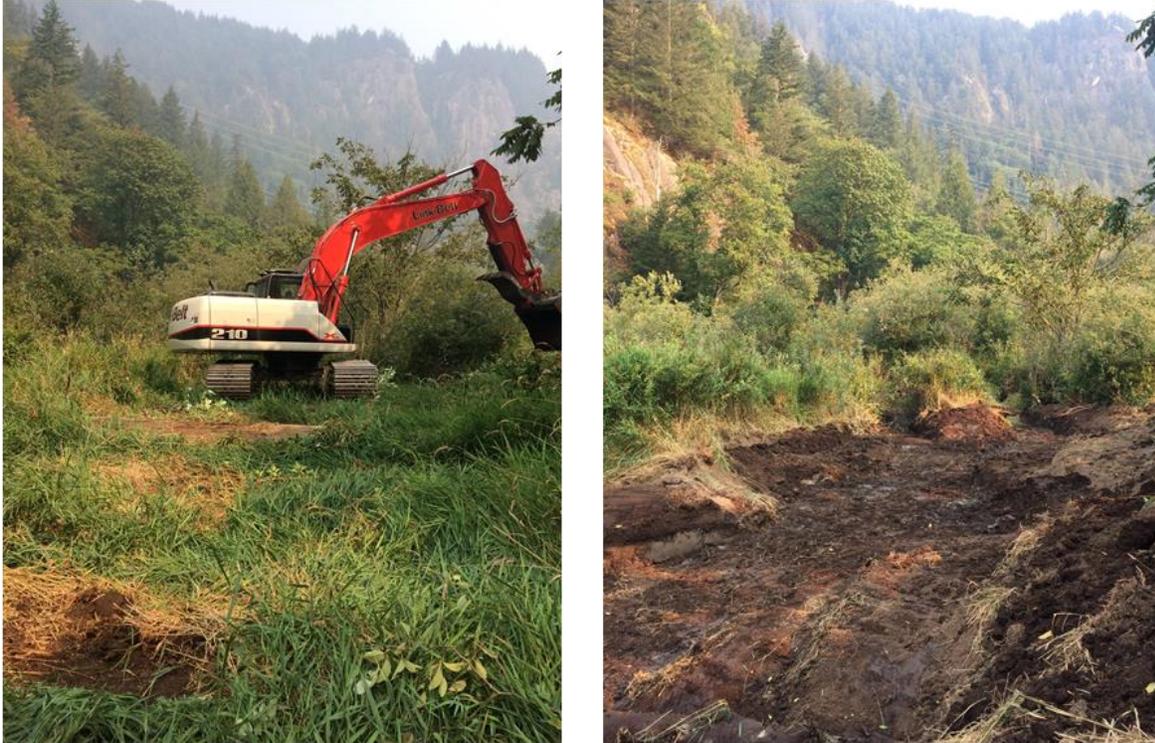
Figure 4: Construction targeted areas that were largely covered in invasive species, retaining as much intact mature native vegetation as possible.

August 17 - Area 4 was created. This is the southernmost wetland on the west of the creek. This small wetland was covered in blackberry prior to construction. Natural vegetation was retained as much as

possible resulting in a large amount of hardhack protruding from banks for amphibian breeding (see Figure 4). Hummocks were added for complexity and contained a mix of spoiled vegetation for habitat complexity. Total area constructed was 0.03 hectares.

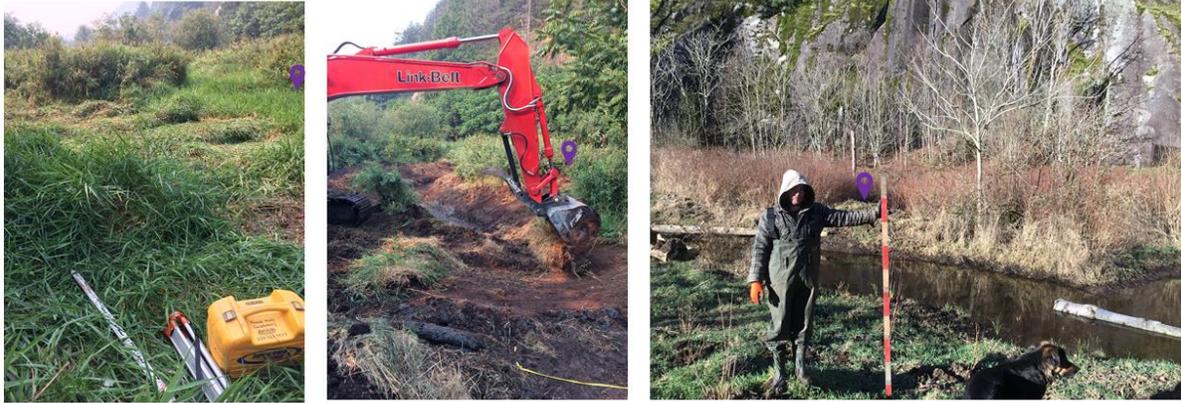
Figure 5: From left to right - before construction, area covered in RCG, during construction - maintaining mature native vegetation while removing invasive species, after - maintained vegetation in background with plant stock in foreground. Purple marker indicates same spot in each photo.

August 21 - Area 2. This area was predominantly RCG and blackberry prior to construction. Excavation focused on the areas covered in invasive species with spoil being placed on patches of blackberry. Area 2 contains two tie-in points connected by a channel contoured to varying depths and widths to add habitat complexity. Large woody debris was added in the form of snags and downed wood. See Figure 5 for before/after comparison. Total area constructed was 0.11 hectares.

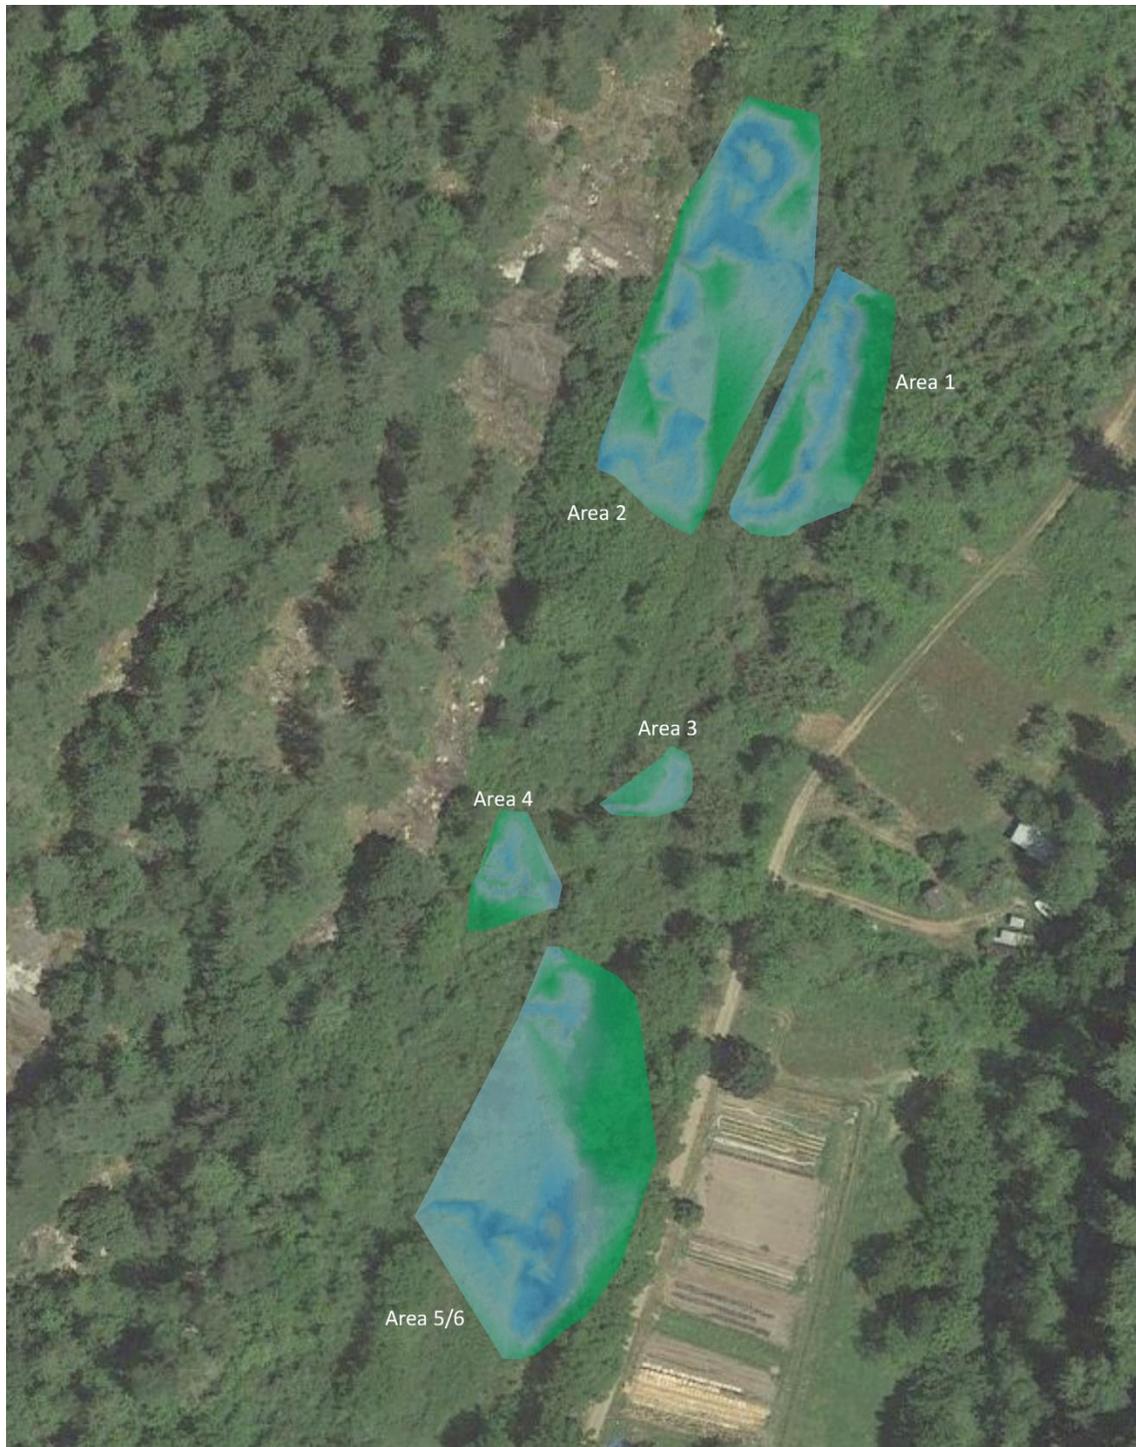
Earthwise Wetlands As-Built

Figure 6: As-built depicting completed works at Earthwise Society in August 2018. All elevations are in meters with reference to sea level (ASL).

Construction began on August 15 when Megna Terra Civil arrived on site. The excavator acquired access to the site from the adjacent property (5989 Golf rd.). This was required to avoid large trees lining the driveway. While the machine was moving into the site it was used to remove blight-infested hazelnut trees on the property. Walnut trees were also pruned to facilitate the movement of the machine to the site. See Figure 5 for as-built surveying map and area nomenclature. In total 0.64 hectares were restored to wetland habitat.

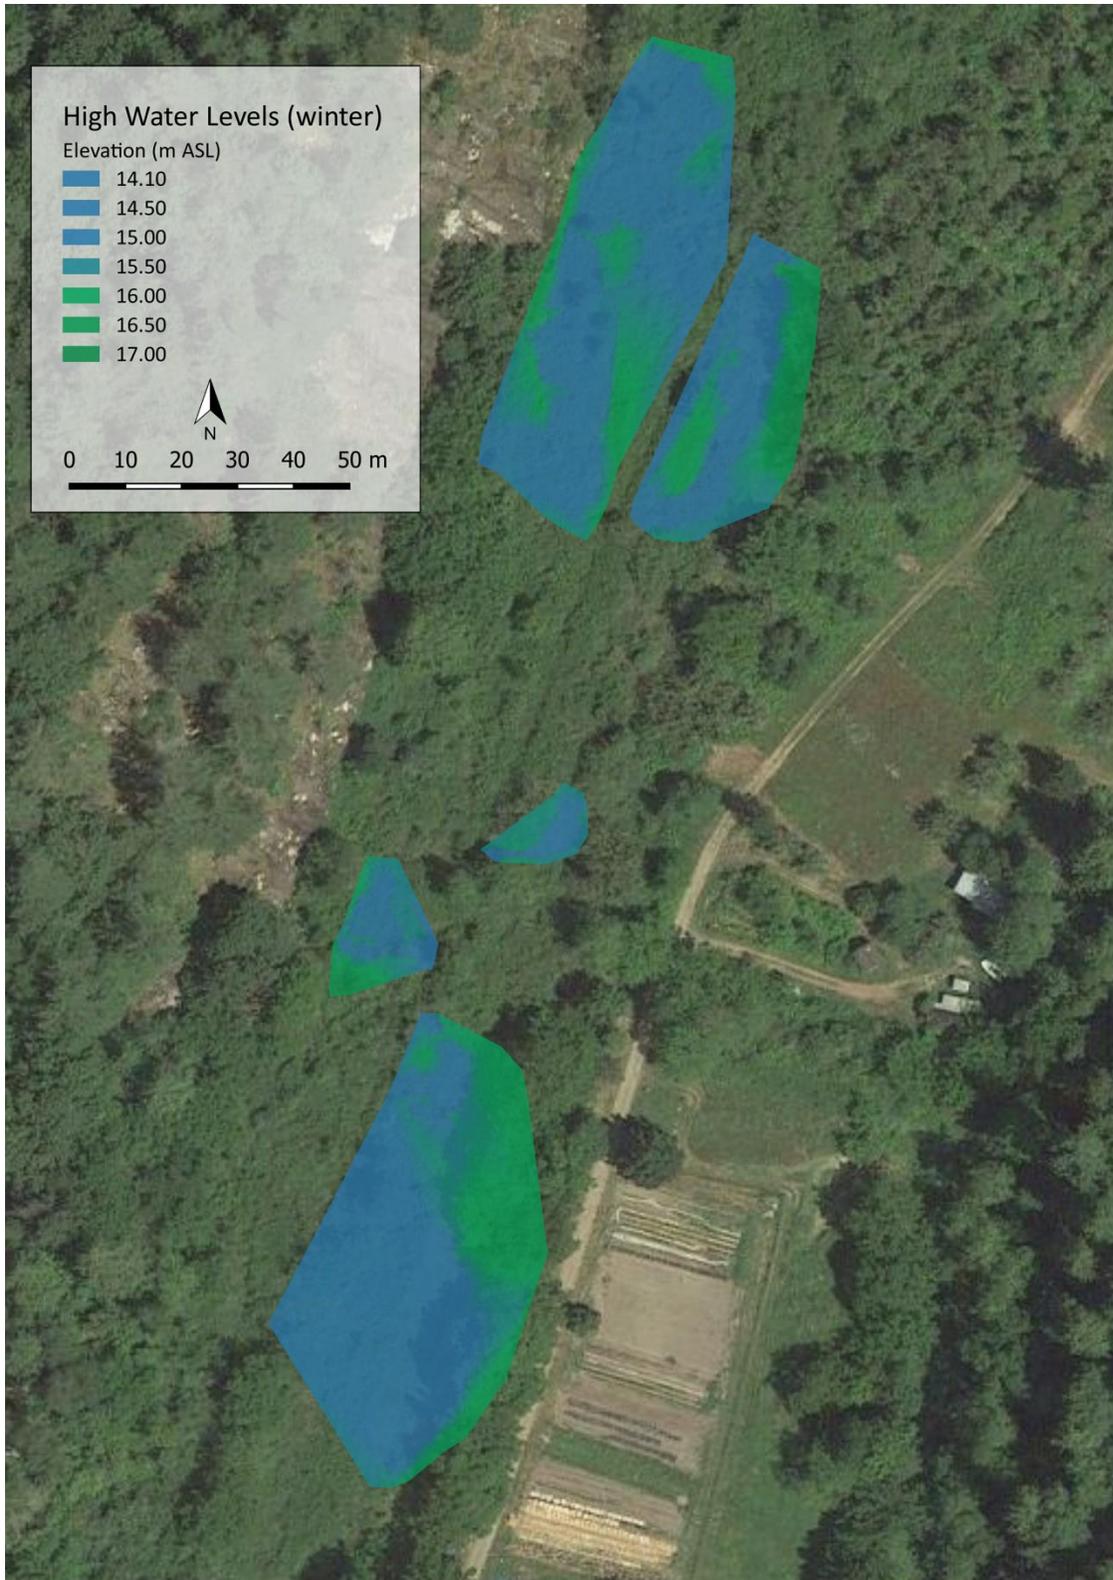
Figure 7: Winter water levels are depicted in blue. The southern-most wetland that will be separated into areas 5 and 6 at low water levels will become one connected wetland. All evaluations are meter above sea level (m ASL).

Area 5 is the small pond created south of the connection to the Miami River west of the driveway. The spoil in this area was placed over a large area to reduce the size of the berms and as such this area is expected to be quite wet during high water periods (see Figure 7). We planted aquatics in this area with a commitment from Earthwise to add necessary riparian shrubs to the area after initial reed canarygrass control is completed (see Next Steps, below).

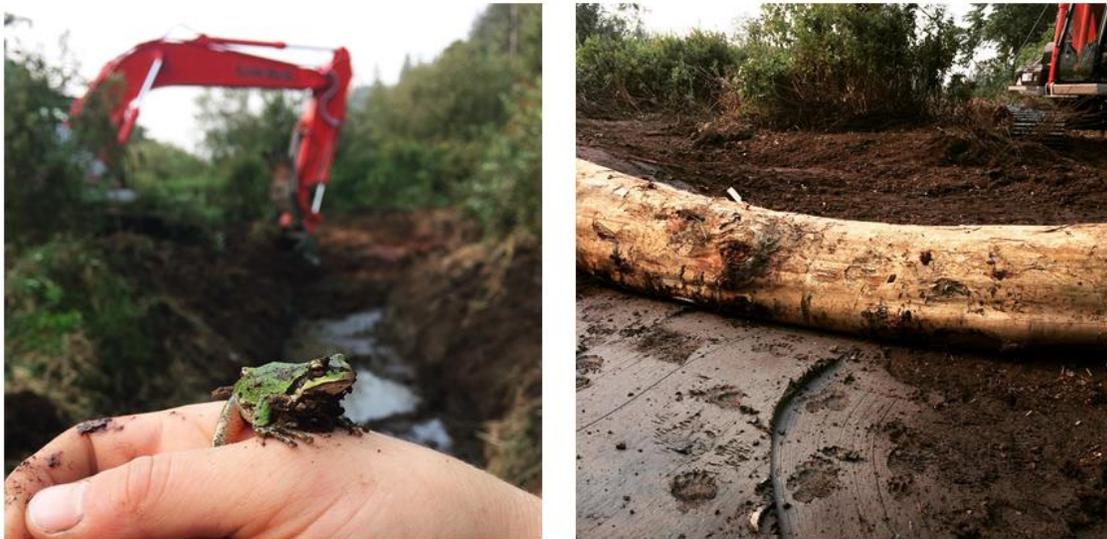
Ongoing monitoring of this site will include photo point stations, fish monitoring, and amphibian monitoring. Monitoring in fall 2018 indicated the presence of Salish Sucker and Coho salmon throughout the newly constructed wetlands. The presence of Northern Red-legged Frogs (*Rana aurora*), Northern Pacific Chorus Frogs (*Psuedacris regilla*), and Northwestern Salamanders (*Ambystoma gracile*) have been documented prior to and during construction works (see Figure 8). Photo point stations were established January 2019 and will be repeated annually in the summer (as funding permits).

Figure 8: The presence of a variety of wildlife has been detected within the restoration project.
