Miami Creek Restoration Report 2019

Natasha Wilbrink
Fraser Valley Conservancy
December 19, 2019

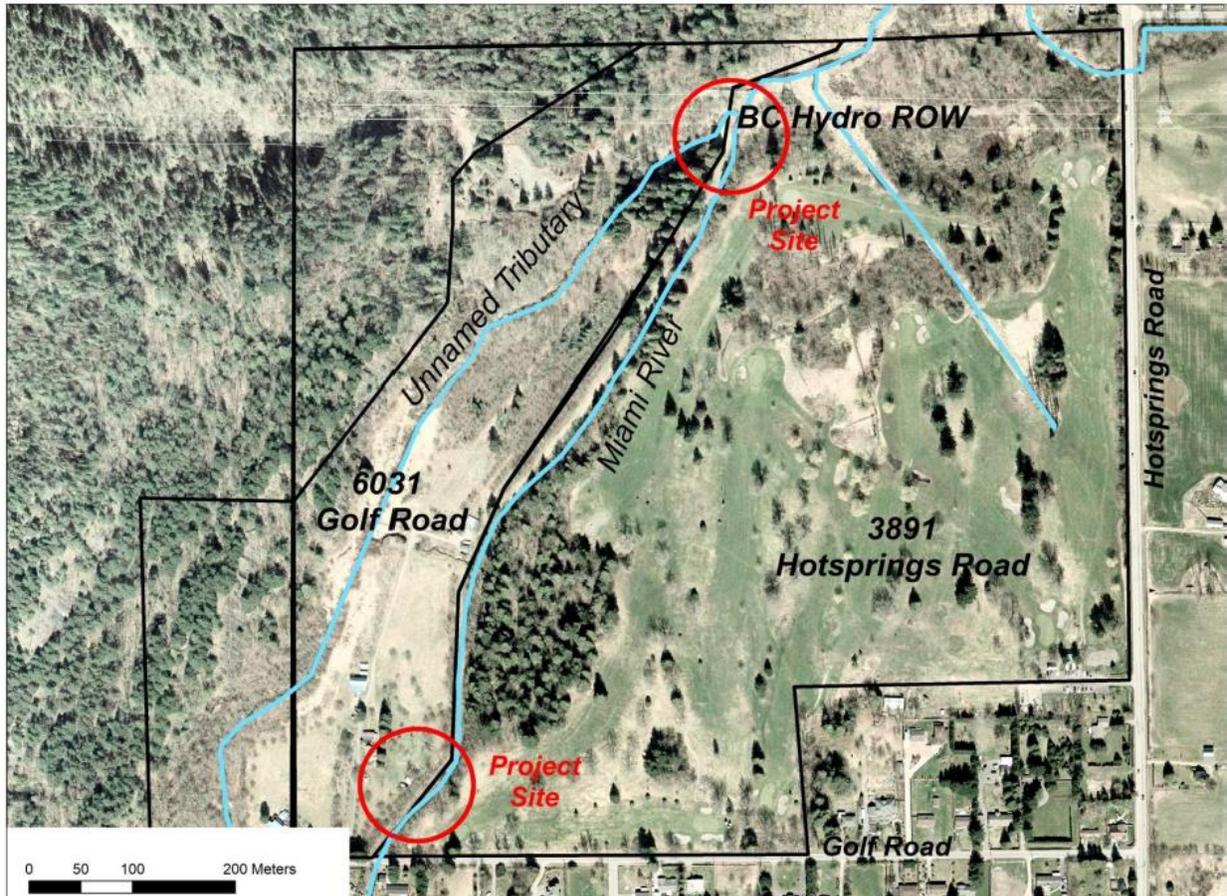
Figure 2: Site overview. North: deep pool habitat South: riffles.

The southern project site is located immediately downstream of the culverted road crossing on Golf Road (see Figure 2). This site is a linear, channelized portion of Miami River. Throughout this reach the stream banks and bed are reinforced with large rip-rap that extends >1m on the streambank shoulder. There is little gradient upstream of this reach which runs through lowland agricultural fields. As a result, there no gravel to create riffles in this reach where the grade would naturally create such features. The rip-rap prevents scouring pools here. A trail runs along the west side of the creek along the top of the stream bank. Riparian vegetation is a mixture of native shrubs and non-native Walnut trees.

This site is located just north of a grove of cedar trees and just south of hydro transmission lines (see Figure 2). This area has little riparian vegetation and is dominated by Reed canarygrass (*Phalaris arundinacea*, RCG) and Policeman's helmet (*Impatiens glandulifera*). The prominence of RCG has led to infilling of the pool that existed at the confluence of Miami River and an unnamed tributary. As a result, the two waterways meet in a narrow channel where they join and flow north into Harrison Lake. This site becomes anoxic during the summer providing little to no habitat for fish.

Project design was completed by Mike Pearson of Pearson Ecological. Habitat limitations for Salish Sucker in this part of Miami River include riffle habitat for spawning and deep pool habitat for rearing and summer habitat. This project aims to provide each of these two habitat features within a 600 meter reach (see Figure 2).

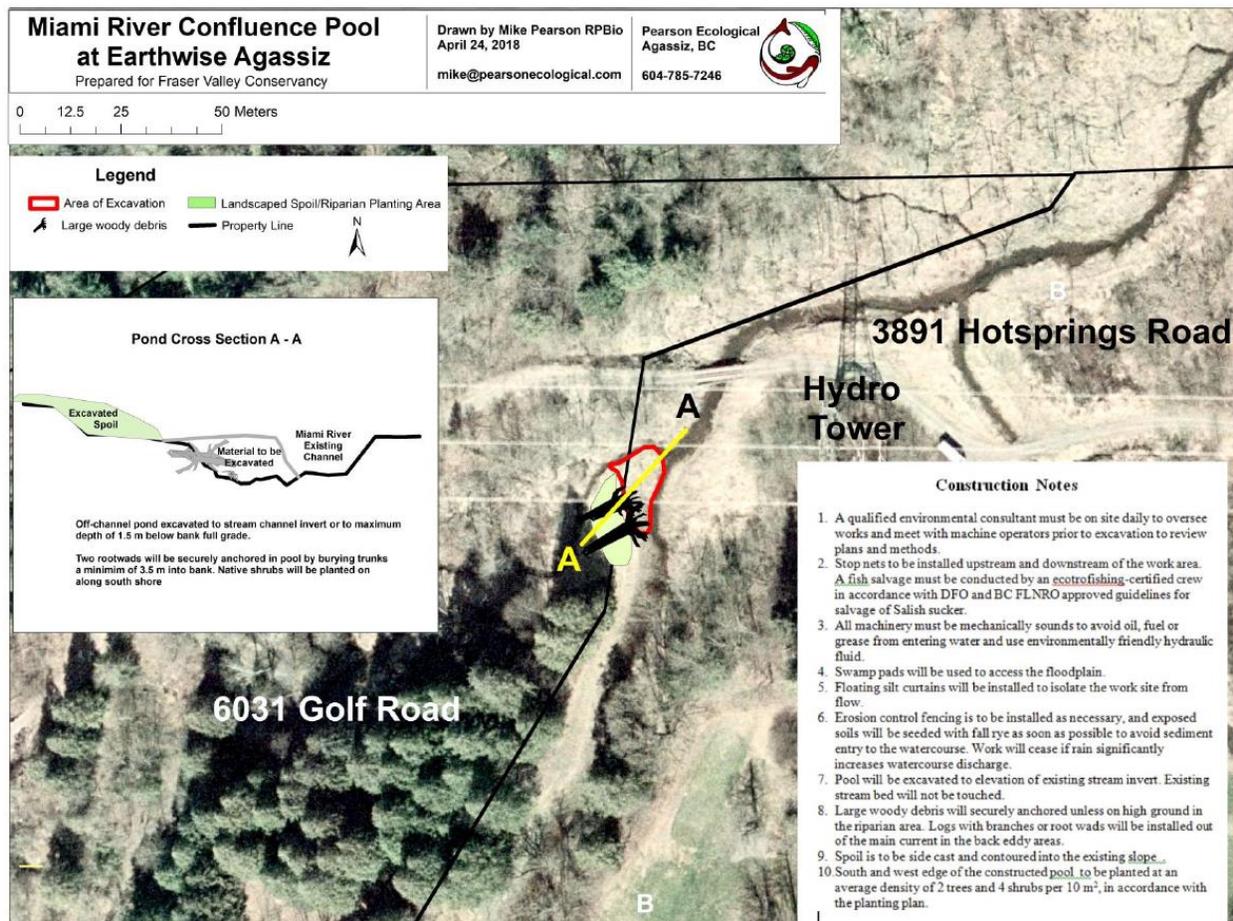
Figure 3: Project design for deep pool habitat at northern project site.

This project area meets all of the criteria of BC Hydro for distance from nearest hydro towers, machinery operation and plant selection. The site will be access from Earthwise Society property to the south. Digging in this site will be limited by water levels and saturation of sediments as swamp pads will not be available in this location. This site will target the removal of vegetation and fine sediments that have accumulated at the confluence of Miami Creek and an unnamed tributary. Prior to construction silt curtain will be installed to prevent sedimentation downstream. A fish salvage will be implemented in accordance with DFO and FLNRO approved guidelines. Deep pool habitat (>0.75m) will be created at the depth of the existing channel invert (see Figure 3). All removed sediments are to be integrated into existing hillslope to south of project area and

seeded with Fall Rye to prevent erosion. Biologically appropriate native riparian species will be planted after construction (see Appendix A – Planting Plan).

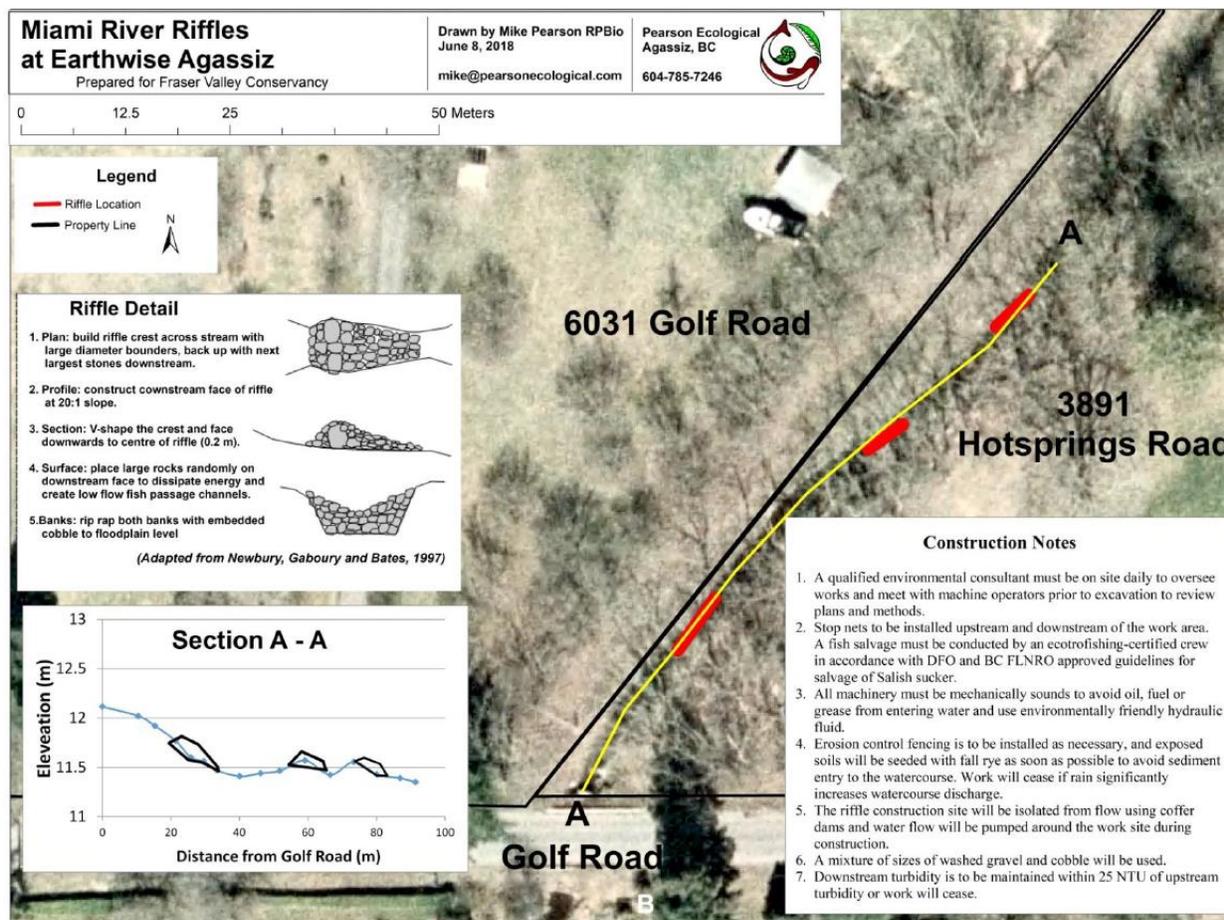
Figure 4: Project design for riffle construction at southern project site.

Designed to provide spawning habitat, a series of three riffles will be installed to replace the rip-rap currently lining the streambed of Miami River. The riffles will be designed to ensure that each step down is no more than 0.5% grade in order to prevent head cutting and eroding banks. The crest of the riffles will be a minimum of 25cm below the invert of the culvert in order to ensure that no flooding will result from their construction. All riffles will be built in the standard Newbury Weir design: A core of boulders to provide stability and washed ‘spawning gravel’ (5-55mm) installed over top (see Figure 4). Rip-rap will be replaced along the sides of the creek to armour the banks. Additional boulders will be randomly placed through riffle gravel to break up flow- dissipating energy and creating fish passable eddies and channels.

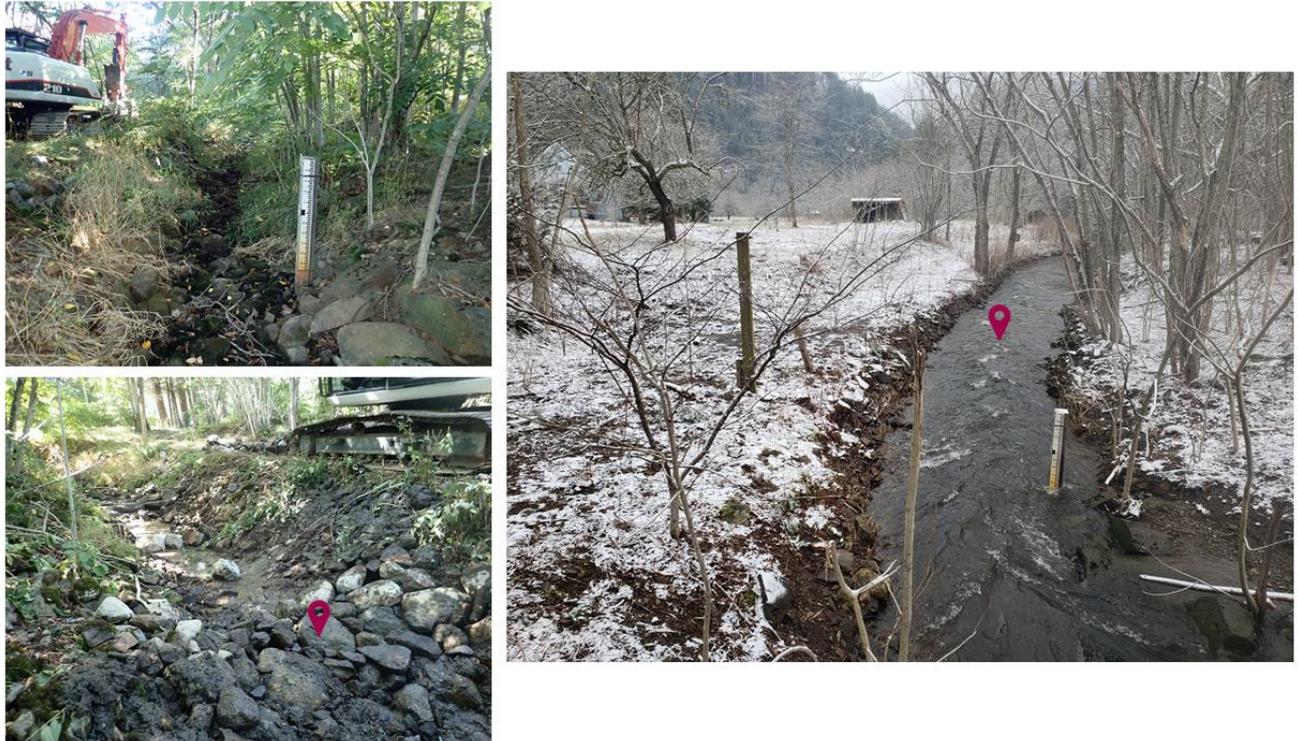
Figure 5: Southern site, riffle installation. Top left: water levels in September and depicts the conditions of the creek prior to construction with riprap covering the bottom and sides of the creek creating a uniform straight channel. Bottom left: rock core of Newbury weir riffle. Right: site during high water February 2020. Marker depicts the same spot in photos.

Construction of the riffle required the removal of multiple layers of rip rap from the creek bed. One layer of large stones was left to armour the unstable soils making up the bed of Miami Creek. Excess rip rap was used to create the core of the riffles that were installed. In total three loads of gravel were required to fill in the three constructed riffles.

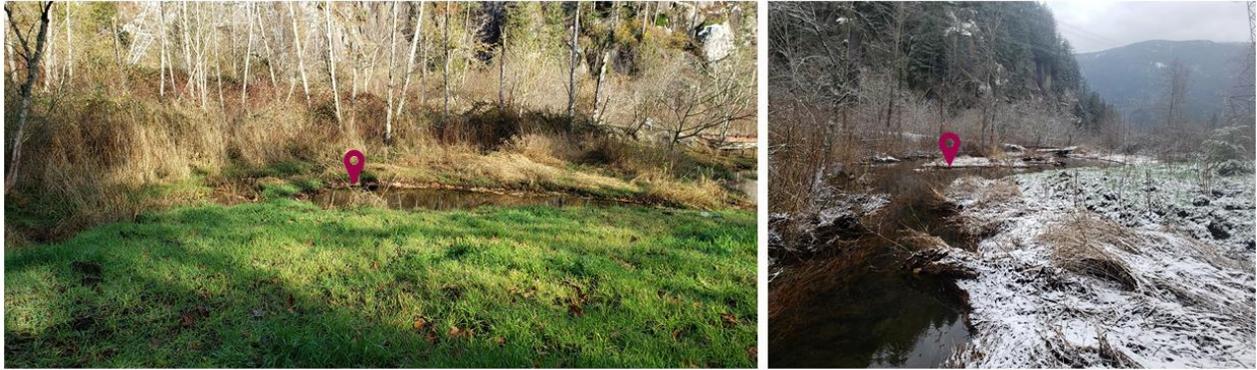
Figure 6: North site post-construction. Left: November 2019, prior to planting. Right: February 2020 during high water.
