Restoration Plan for Gordon's Brook Marsh

Phases II and III

in Aldergrove Regional Park, British Columbia.

Balance Ecological on behalf of the Fraser Valley Conservancy and BC FLNRO

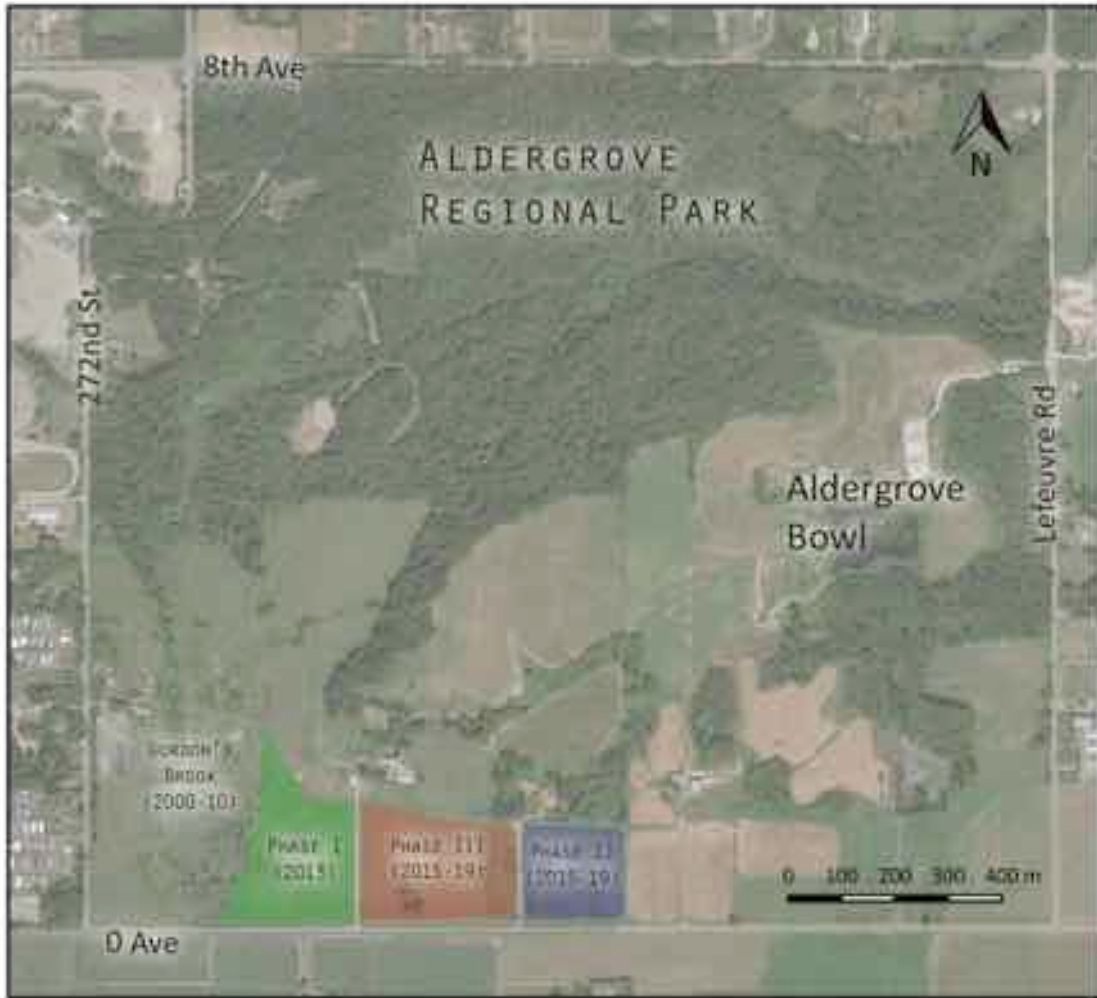
Figure 1. Location of Phases I to III in Aldergrove Regional Park.

The target area encompasses 12 Ha that can reasonably be split into two distinct areas separated by a compacted gravel driveway. We refer to the two areas as Phase II and Phase III, with Phase I referring to the wetland constructed in 2013 directly to the west of the target area (Figure 1). Phase II is the eastern-most section, with earthworks planned for 2016, and Phase III the central section between Phases I and III, with earthworks planned for 2017.

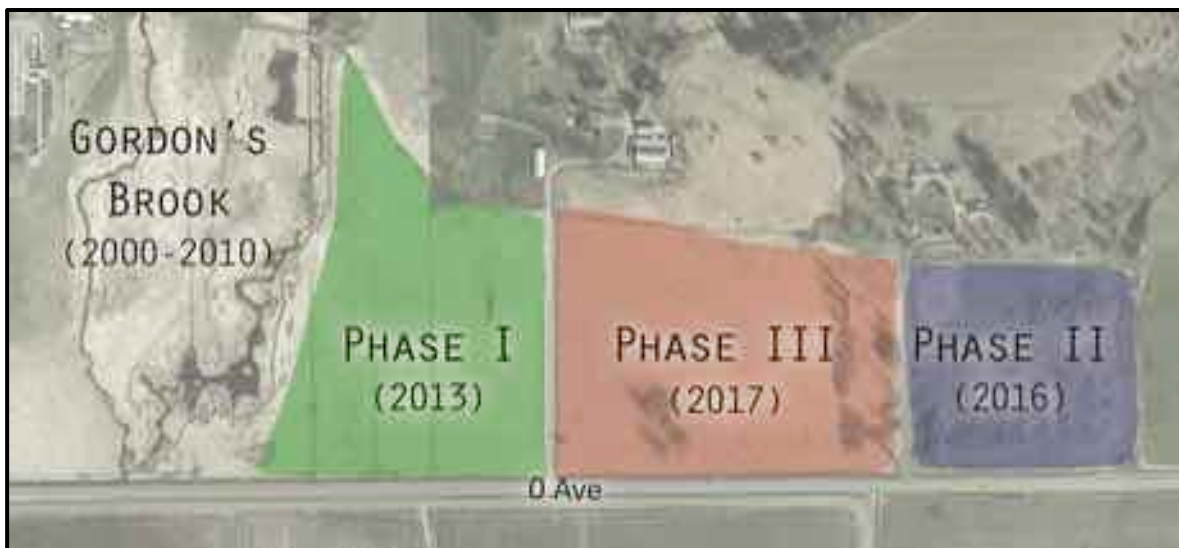
Figure 3. Phases of Gordon's Brook Wetland restoration in proximity to Gordon's Brook complex.

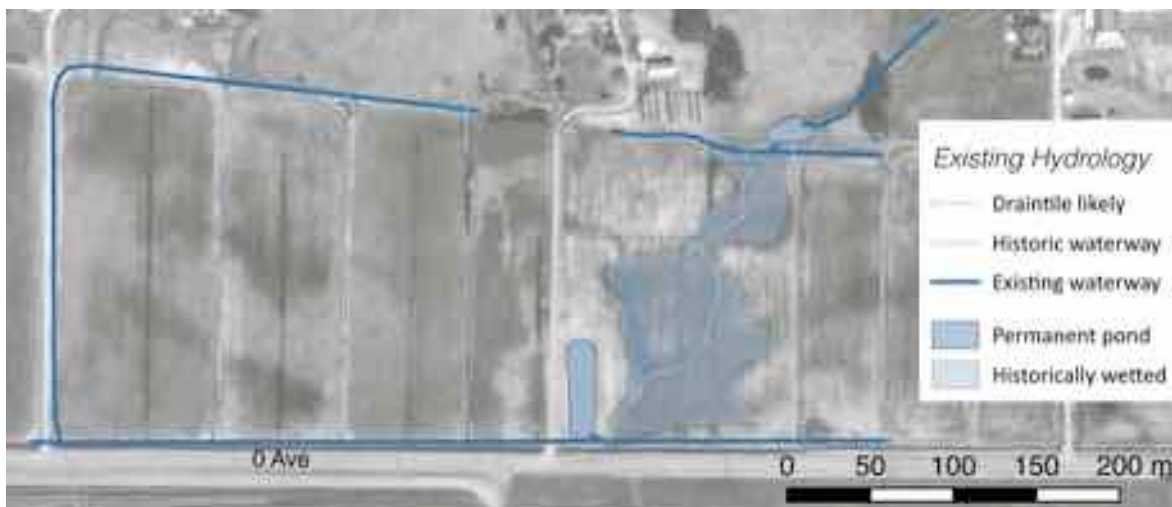
Figure 5. Location of existing and historic drainage features, overlain on orthophoto image from 1979.

Historic orthophotos from 1940 – 1990 show the landscape changed little over the years. However, one particularly useful photograph from 1979 was taken during a wet period and clearly shows the location of depressions, historically wetted areas, ditches and drain-tile.

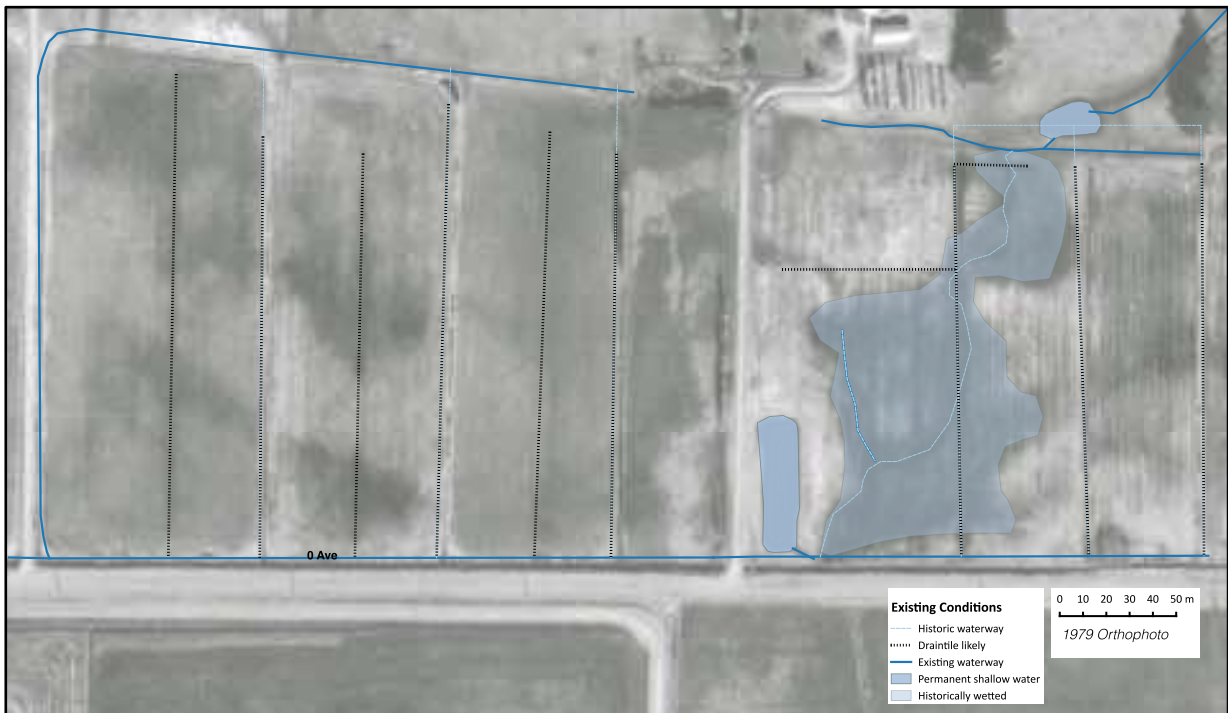
Figure 9. Existing hydrology indicating location of drain tile as identified on 1979 orthophoto.

Drain tile was identified in the field when digging test pits, and their locations appear on historic orthophotos (Figure 9). Drain tile was likely installed in the 1970s, following initial ditching to lower water tables (visible in 1969 photos). The identified drain tile was corrugated slotted plastic,

with no drain rock to protect the plastic. This makes finding the tiles more difficult, but our chances are improved by the photos. Where drain tile is found, it will be plugged to prevent drainage to the ditches

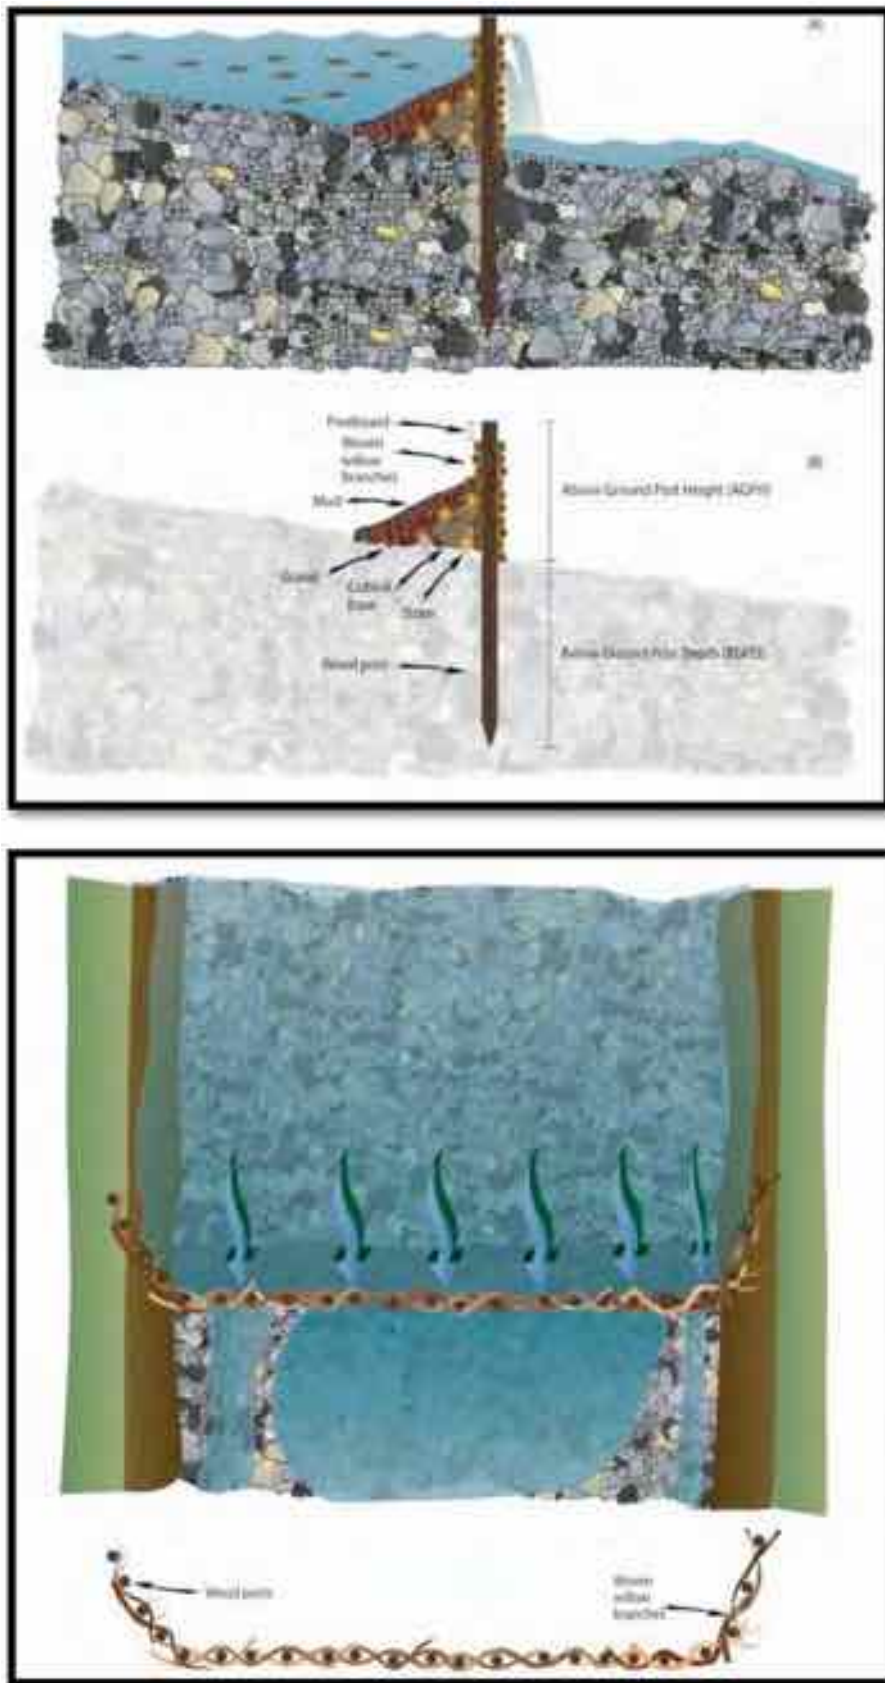
Figure 11. Diagram of a starter dam, with design detail and necessary material needed for construction. (top) side view (bottom) plan view. From Beaver Restoration Guidebook page 84 (Pollock et al. 2015).

A starter dam is made up of posts pounded deep into the ground at 0.5 m intervals, and woven loosely with willow branches (Figure 11). These dams are permeable and do not generally hold enough water to form a pool in the short term. However, if well placed the starter dams will form natural starting points for beavers to build and fill a deeper wetland pond. If beavers do not choose to use the area, it will be possible to either reduce permeability by placing cobbles, sands, silts any vegetation upstream of the starter dam. However, with increased groundwater from drain tile and ditch decommissioning, it will likely not be necessary to hold water back with a weir to recover wet land and shallow ponds. Willows planted around the dam structures, and in particular on the spoil piles, will entice beavers and we anticipate that several of the starter dams will have attracted beaver engineering prowess within 5 years of construction.

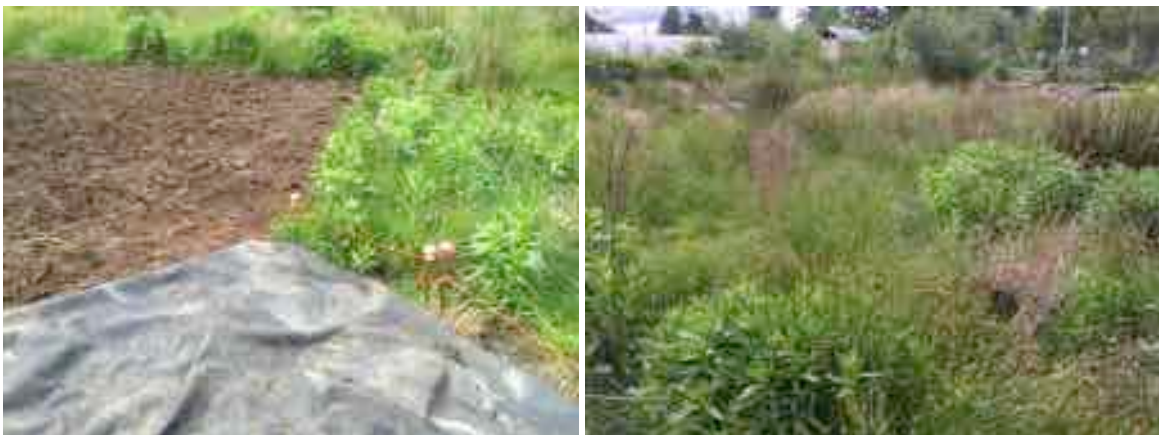
Figure 14. Left: Haliburton smothering methods. Clockwise from front: Pond liner, post-treatment, and one-year post-treatment. Right: One year post-treatment in the foreground; two years in background.

- 1) Remove biomass by mowing and raking / haying grass;
- 2) Immediately apply 45Mil (1.14 mm thickness) pond liner to the target area, and allow to sit for one year. Weigh down as necessary with stones / sandbags to ensure continued coverage.
- 3) In the following Spring, remove liner and apply cardboard as well as leaf mulch.
- 4) Seed over the leaf mulch and plant through the mulch / cardboard.
- 5) Remove returning reed canarygrass patches manually, or re-treat larger patches as necessary.

Challenges to upscaling this treatment include initial cost of material – Pond liner costs between \$1.00 - \$1.50 per square foot, and the requirement that liner be adequately weighed down and monitored to ensure continuous coverage and maintenance from wind events.

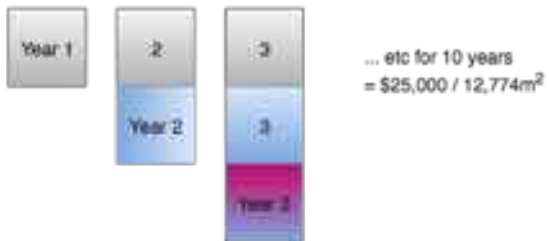
**EPDA 45Mil PondGard Fish-safe pond liner
Materials Cost and Impact Estimate
\$1 / sqft**

Annual budget of \$2,500 = 2,500 sqft = 50' x 50'
Lifetime of product = 10 years

350' x 400' - 50' x 50' treated over 11 years
= 137,500 sqft = 12,774 m²

Followed by 25,000 ft² / 2,322 m² per year
(if continue to replace 2,500 ft² annually)

Cost for 1 Ha = 10,000 m² = 107,639 sqft = \$107,000

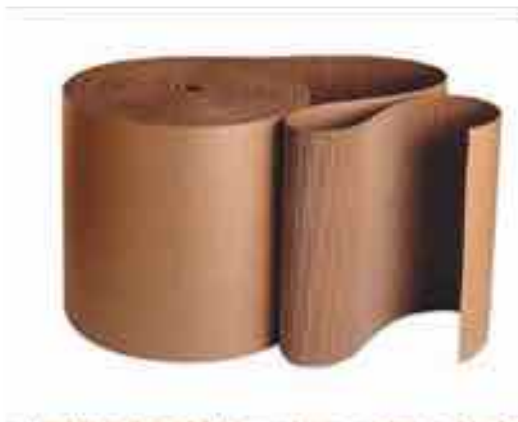
**Cardboard Materials Cost and Impact Estimate
\$100 / 1000 sqft**

4' x 250' Single Face Corrugated Rolls = 1000 sqft = 12,774 m²

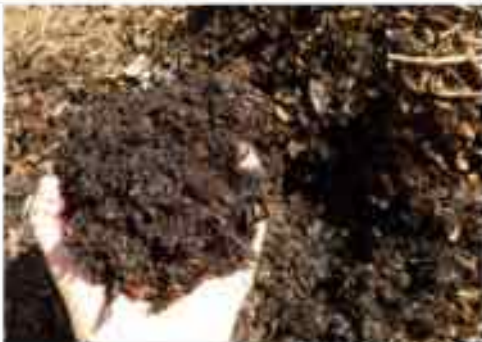
**Mulch Materials Cost and impact Estimate
\$25 / cubic yard**

2 inches depth for 2,500 sqft = 15.4 cubic yards

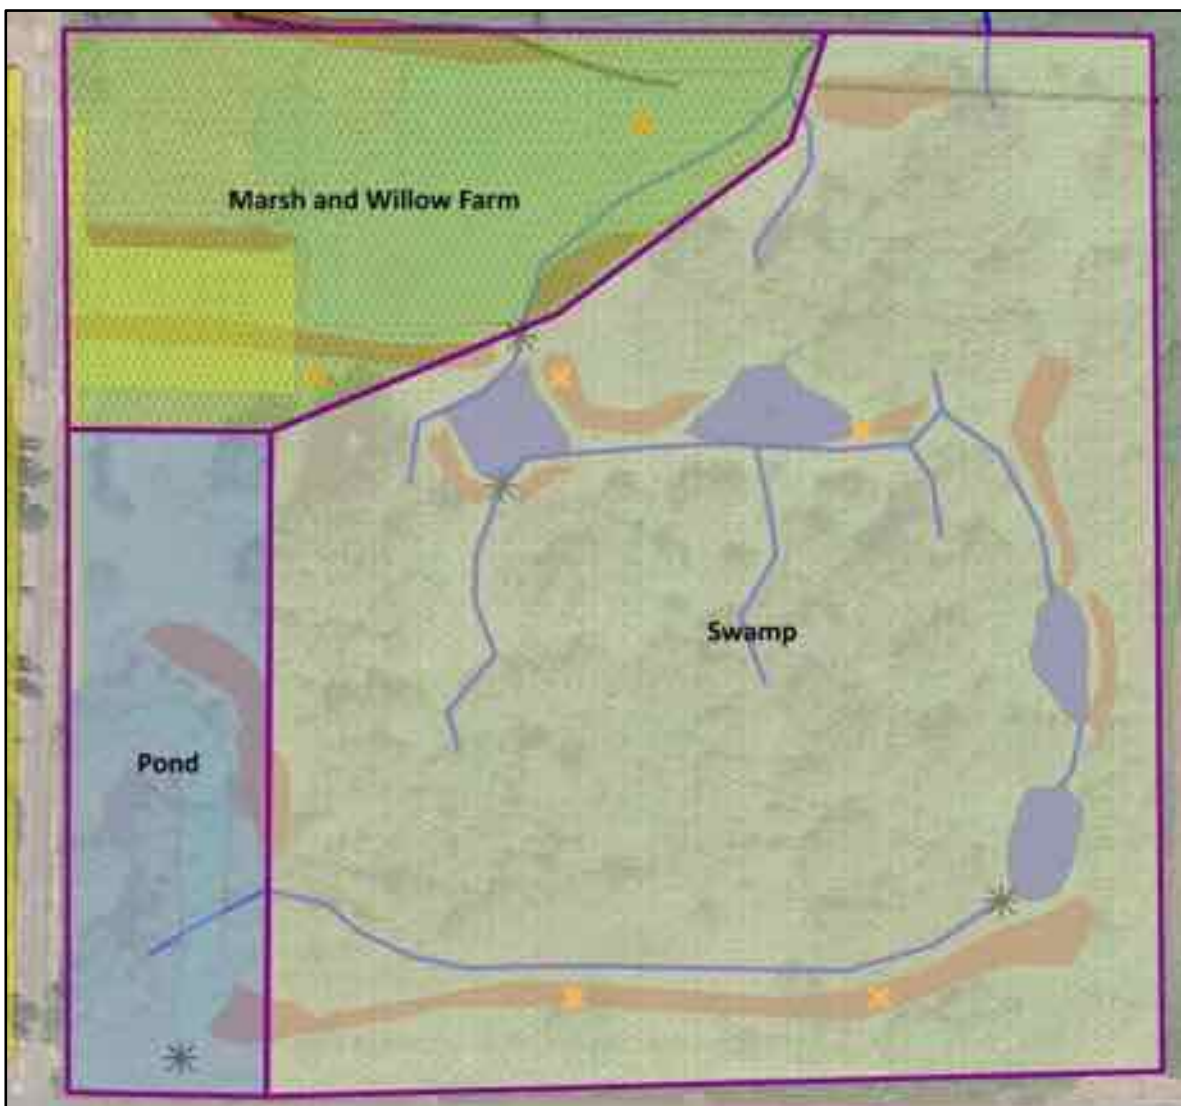
Figure 16. Phase II Treatment Zones.

Phase II is on the east end of the target area, and will be treated in three different sections: 1) the Pond, in the south-west corner; 2) the Swamp, the eastern, partially wooded sections, and 3) the Marsh and Willow Farm, in the north-west corner (Figure 16. Phase II Treatment Zones.). We will work from the south-east corner in a counter-clockwise manner – downslope to upslope – to allow for poor weather in the late summer so that we will be working in the driest, upslope areas last, and connecting surface water to the complexed site after all construction works are completed. Construction activities will take place over three weeks in August or September, depending on contractor availability.
