CONSTRUCTION REPORT  
SHALLOW MARSH RECONSTRUCTION  
in ALDERGROVE REGIONAL PARK

February 26, 2014

Monica Pearson, RP Bio  
BALANCE ECOLOGICAL  
Vancouver BC

# Shallow Marsh Restoration at Aldergrove Regional Park

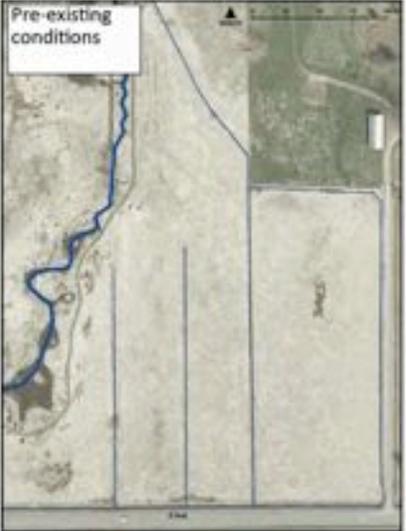
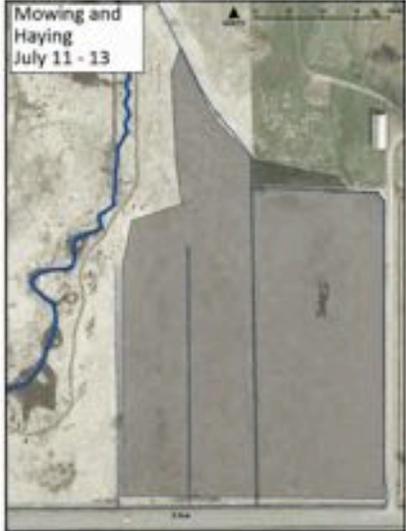
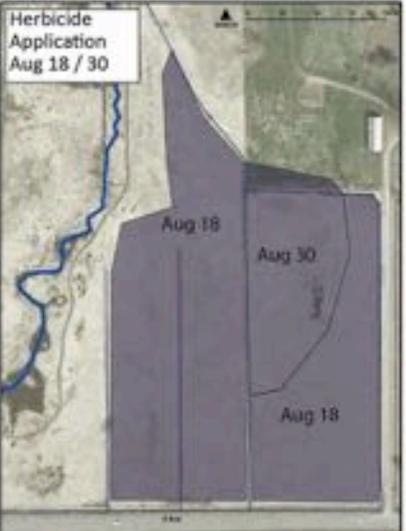
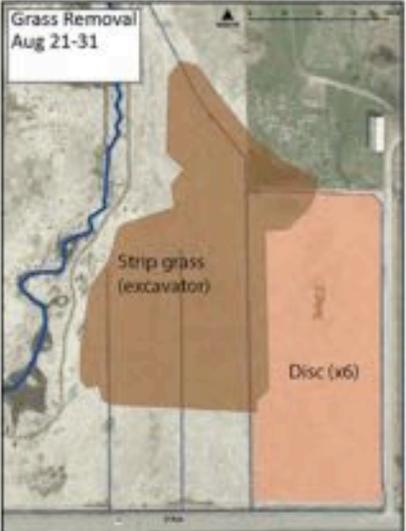
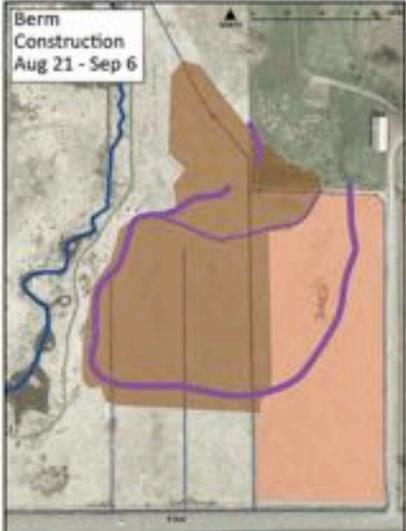
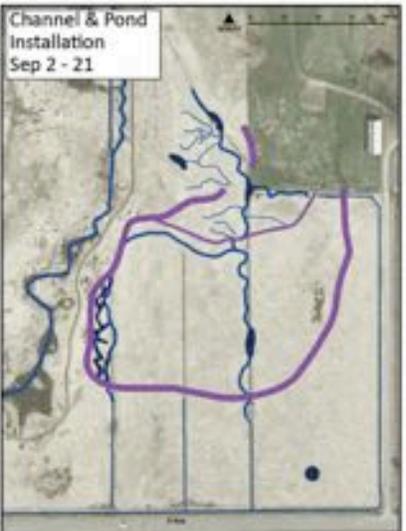
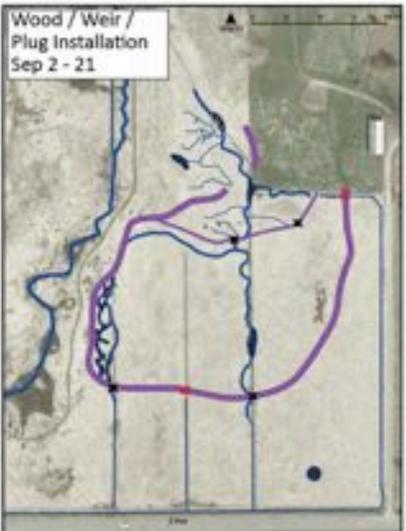
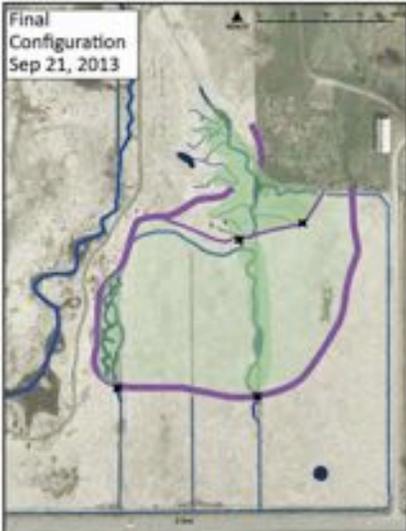
Construction stages  
July - September 2013  
Impacted area: 5.4 Ha

Figure 1. Construction phases of the marsh at Aldergrove Regional Park from July - September 2013.

Grass regrowth was treated with a glyphosate-based herbicide (Roundup WeatherMax<sup>®</sup> formulation). Unfortunately, chemical control was not performed to design standards due to administrative and logistic delays. Permits were delayed due to a change in administrative structures within Metro Vancouver, resulting in a late start on mowing (July rather than June). Additionally, the size of the project (5 Ha) was too small to be an attractive work opportunity for commercial custom spray operators, and was delayed several times as contractors postponed application in favour of larger projects. Finally, a local farmer performed the application using smaller equipment that was more expensive (time consuming) to operate, had a higher margin of error in spray (missed patches), and too late to allow for resprouting and reapplication before construction work could begin. Herbicide was applied once with a boom sprayer across the field west of Central Ditch and the southern portion of the east field on August 18, and on the northern portion of the east field on August 30 (Figure 1).

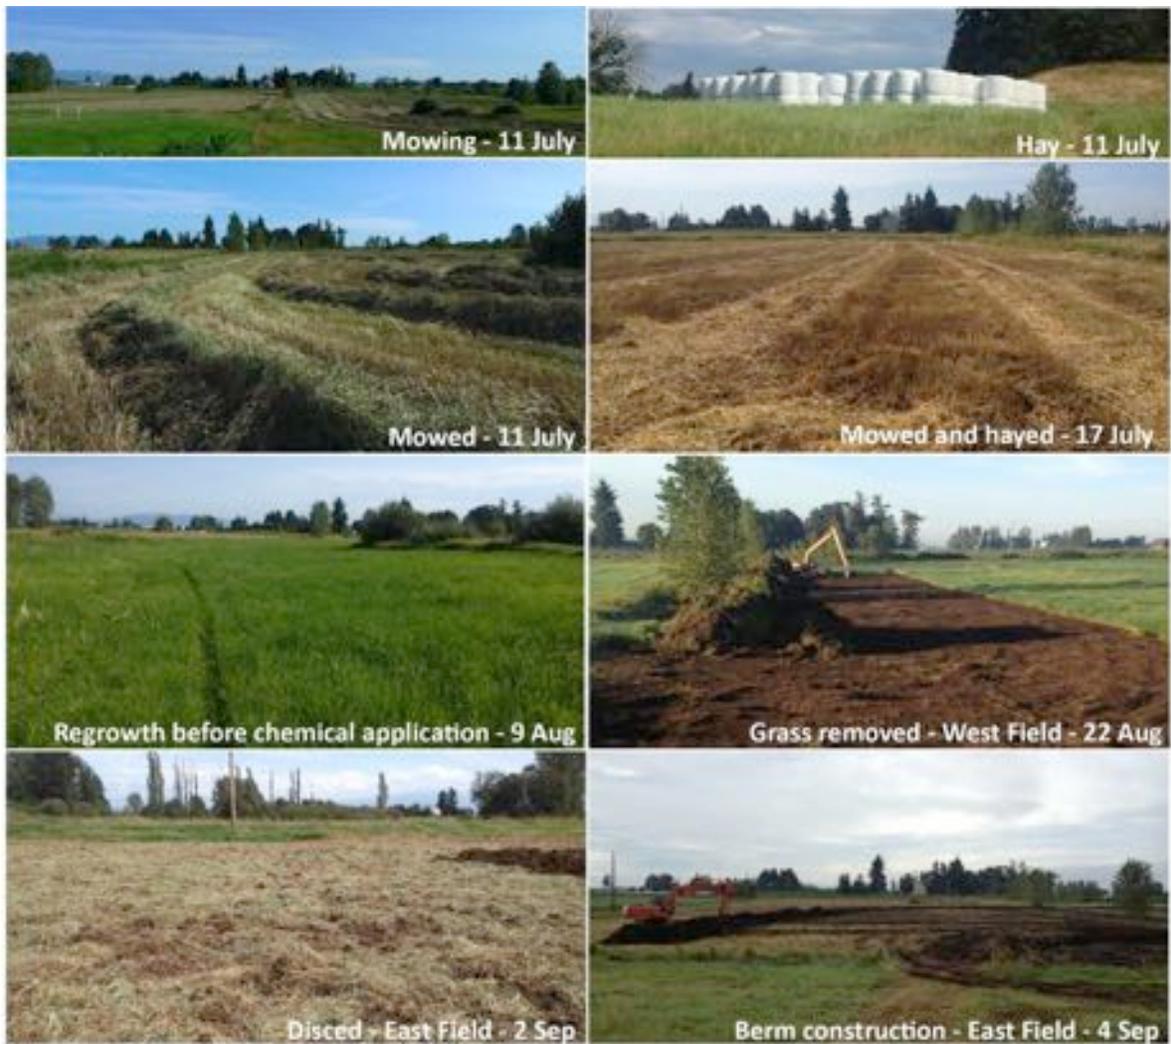
Grass was stripped from the surface of the west field as well as the 'ponds' area and used to build berms for water control structures. Stripping involved removing the growth and a shallow portion of roots and topsoil. The east field was not stripped of grass but disced with a rotator disc 6 times to break up the grass mat and soil. Berms built of grass will settle over the first two years post-construction, and will require re-grading and smoothing to develop a walking trail.

Figure 2. Site preparation to control reed canary grass prior to wetland construction at Aldergrove Regional Park in 2013.

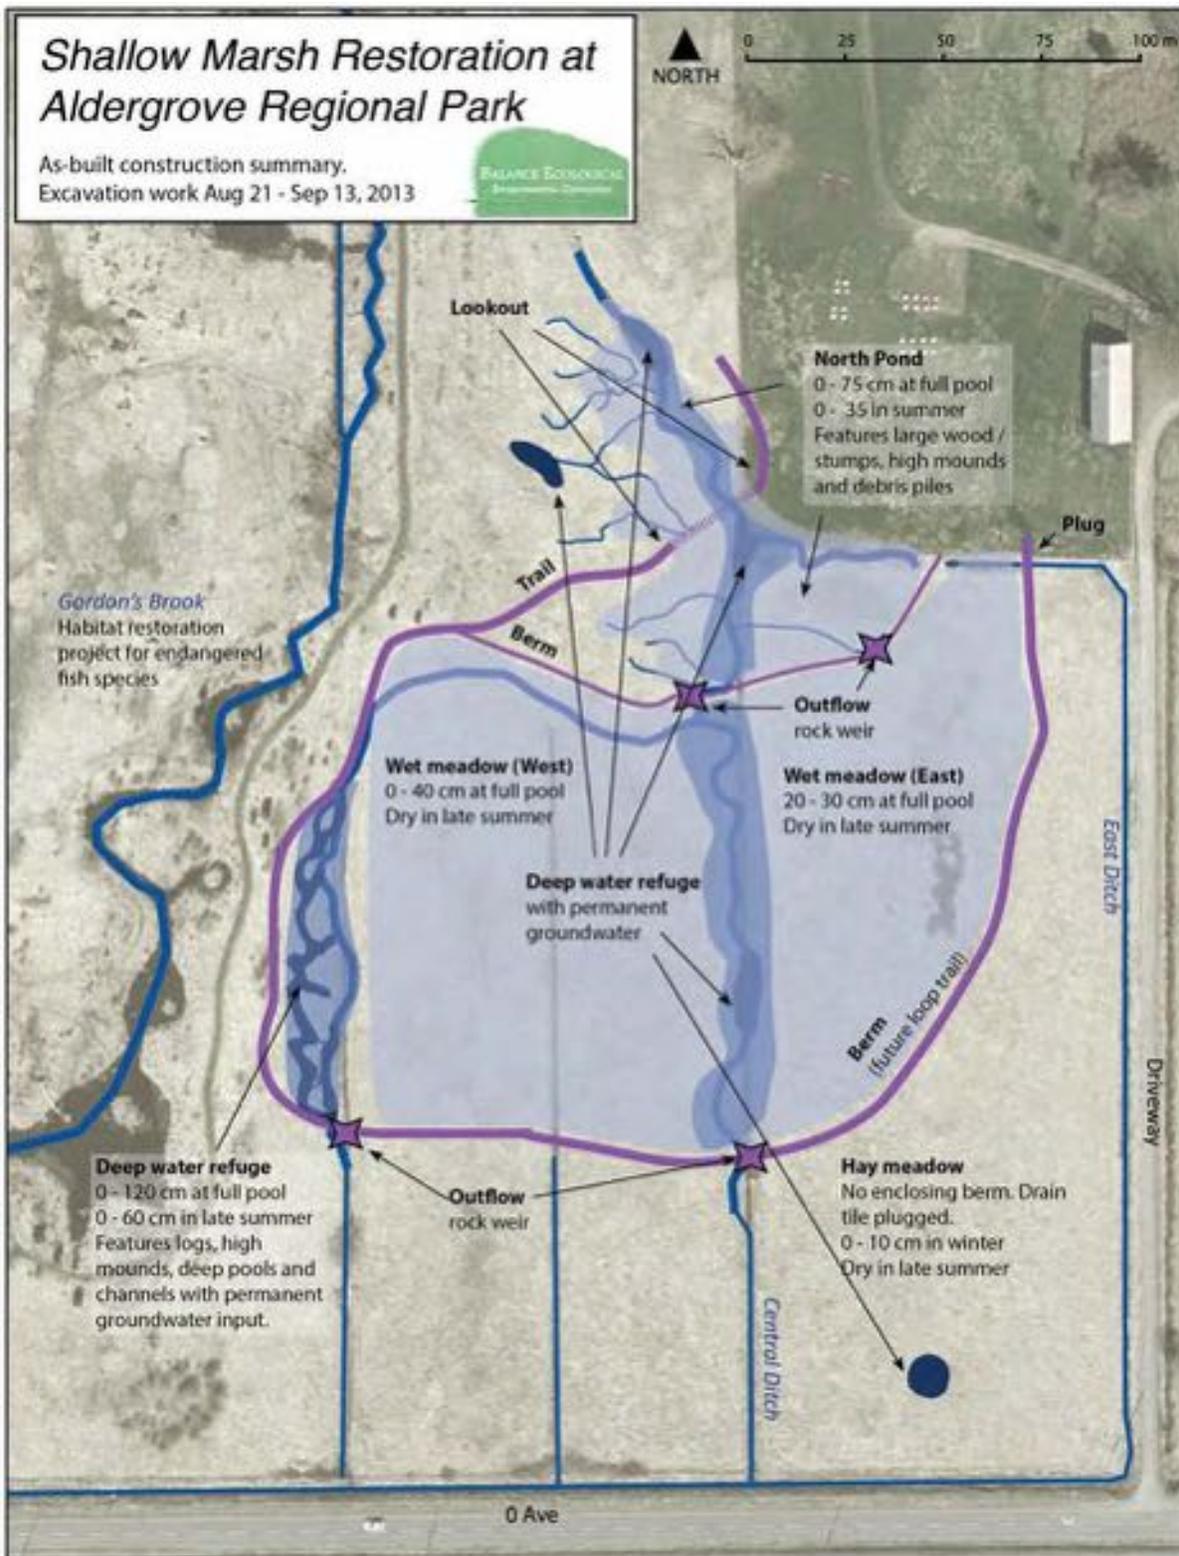
The constructed project is generally divided into a north Pond zone and south Marsh zone by a constructed berm. A second berm (south berm) constrains a constructed marsh / wet meadow that is bisected into east and west fields by a central drainage channel. The marshes drain to the south across rock weirs in the south berm (a future Loop Trail) into local agricultural drainage ditches. Deep-water refuges access permanent groundwater to ensure wetted habitats remain available for aquatic wildlife year-round.

Figure 3. Summary figure of constructed habitat at Aldergrove Regional Park indicating major features.

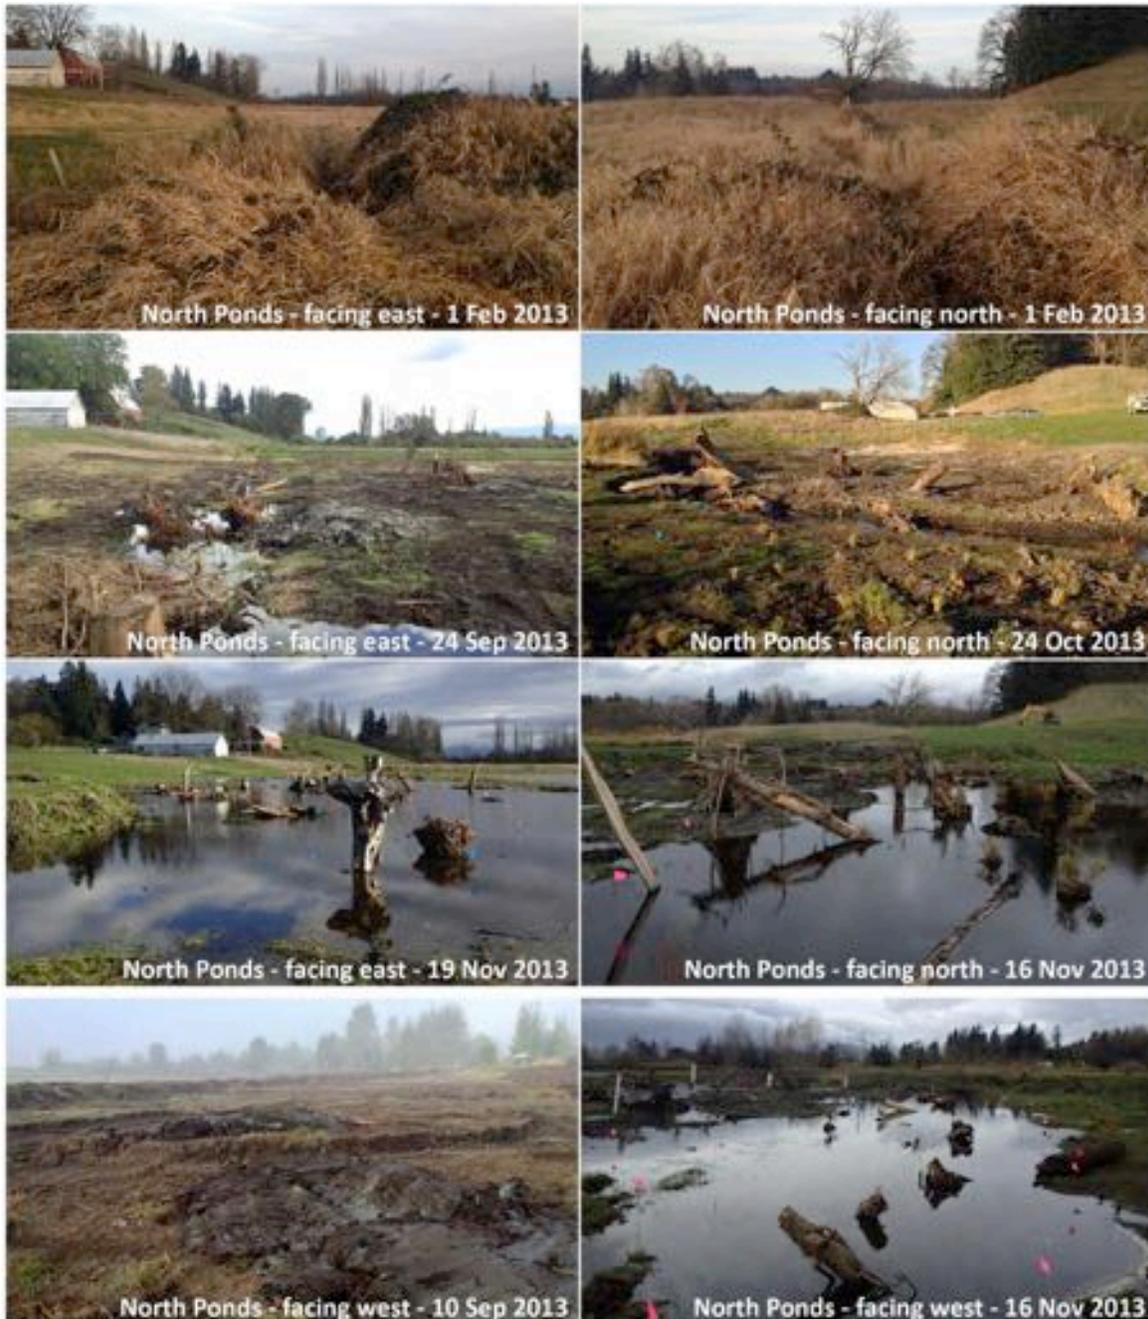
The Pond zone is complex, with channels, deep pockets, high mounds, and dense placement of coarse woody debris and scrub piles. Topological variation in the ponds reaches 1.5 m from top of mound to adjacent pond invert, with a diversity of sharp vertical edges alongside gentle slopes. Three large (100 m<sup>2</sup>) deep water pools and connecting channels were constructed to provide low-water refuges to aquatic fishes and frogs during the late summer months; these ponds were constructed alongside existing shrubby vegetation that provide pre-existing shade and cover structure.

Figure 4. Pre-, during and post-construction images of the north Pond zone.

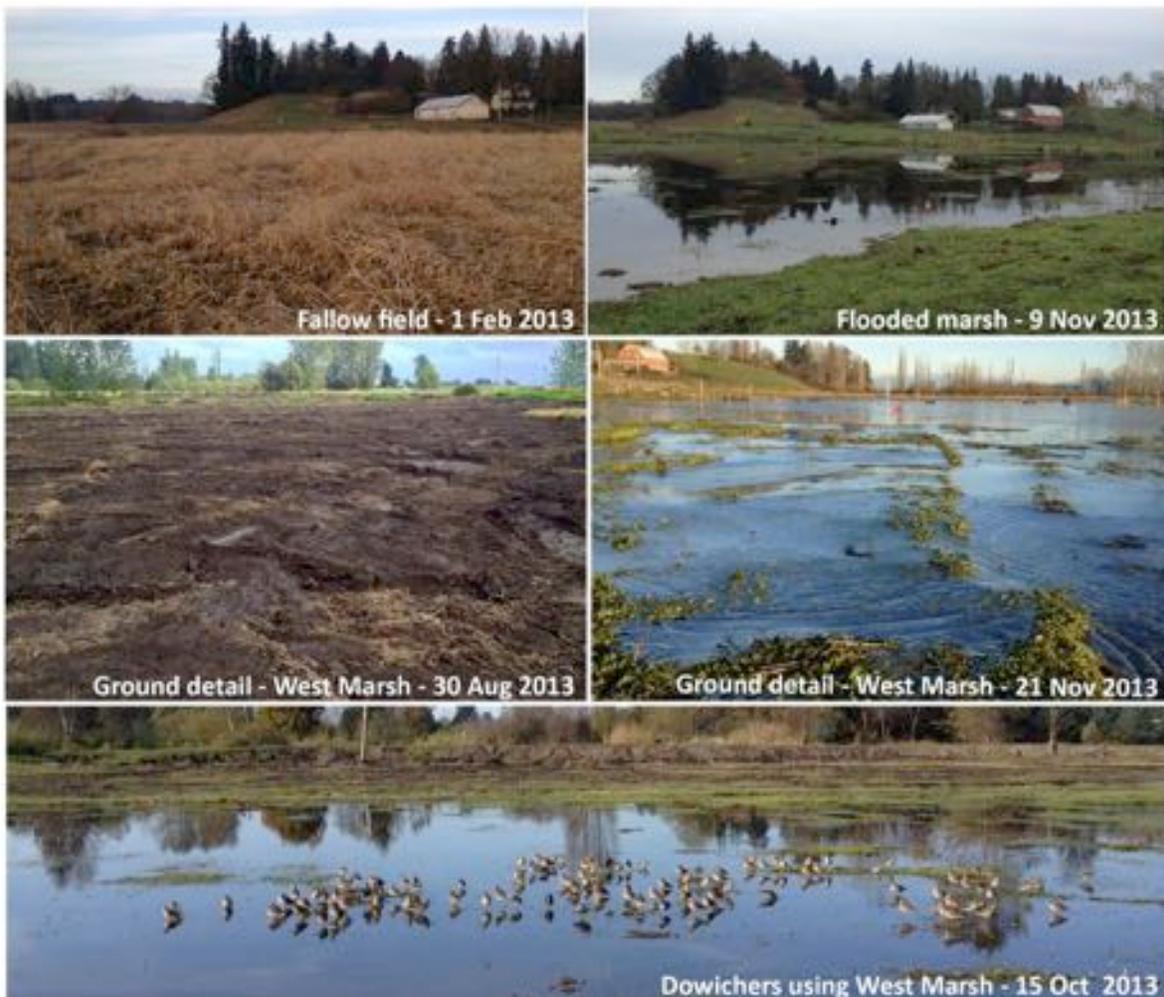
The Marsh comprises two marsh-meadows divided by a channel with deeper pools and channels bordered by the south berm. Topological variation in the fields is low, with a gradient of 0.4 m from north to south over 100 m. The east field is shallower than the west; it had less disturbance to the ground during construction as vegetation was disced with a tractor rather than stripped with the excavator. Stripping grass with the excavator allowed us to use the material to build berms, and also to increase microtopographic complexity. The field is level enough to accommodate a tractor for maintenance, but rough edges were maintained to provide a diversity of opportunities for naturally colonizing plants and invertebrates. Both fields are designed to flood in winter to a maximum of 40 cm depth, slowly drop water levels through the summer via evapotranspiration, and dry in late summer / early fall to allow for mowing or other invasive grass maintenance activities.

Figure 5. Pre-, during and post-construction images of the wet meadow / marsh zone. This zone was used by birds and odonates before construction was complete, particularly Killdeer and Dowichers.

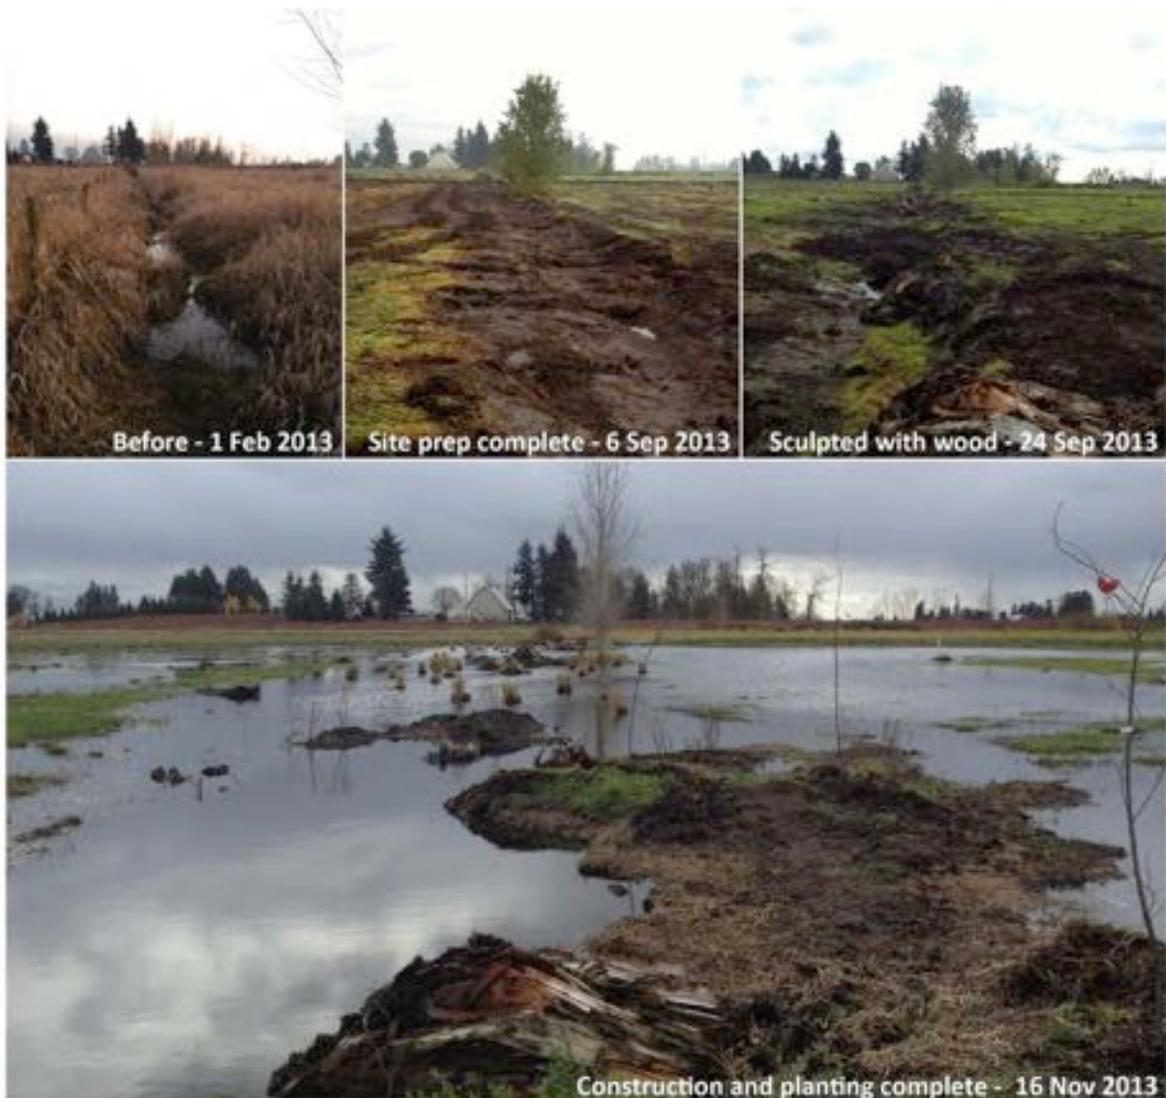
A central channel bisects the east and west fields, providing deeper habitat opportunities and a conduit for heavy flow in rain events. A straight, narrow agricultural ditch was shallowed, widened and sculpted to increase its meander. The channel does not have a continuous gradient from north to south, but at times shallows to force water over the adjacent fields. Our intention was to give water somewhere to go, but to make it work to get there. Mid-way between the north and south berms is a 100-m<sup>2</sup> deep permanent water refuge pool alongside existing cottonwood trees. Coarse wood was placed at intervals, particularly at the edge of steeper gradients where water will flow continuously in winter months. This is intended to provide overwintering habitat for Oregon Spotted Frog.

Figure 6. Pre, during and post-construction images of central channel bisecting east and west fields. Facing south from berm. A deep water refuge was dug beneath the existing cottonwood trees seen in the photos.

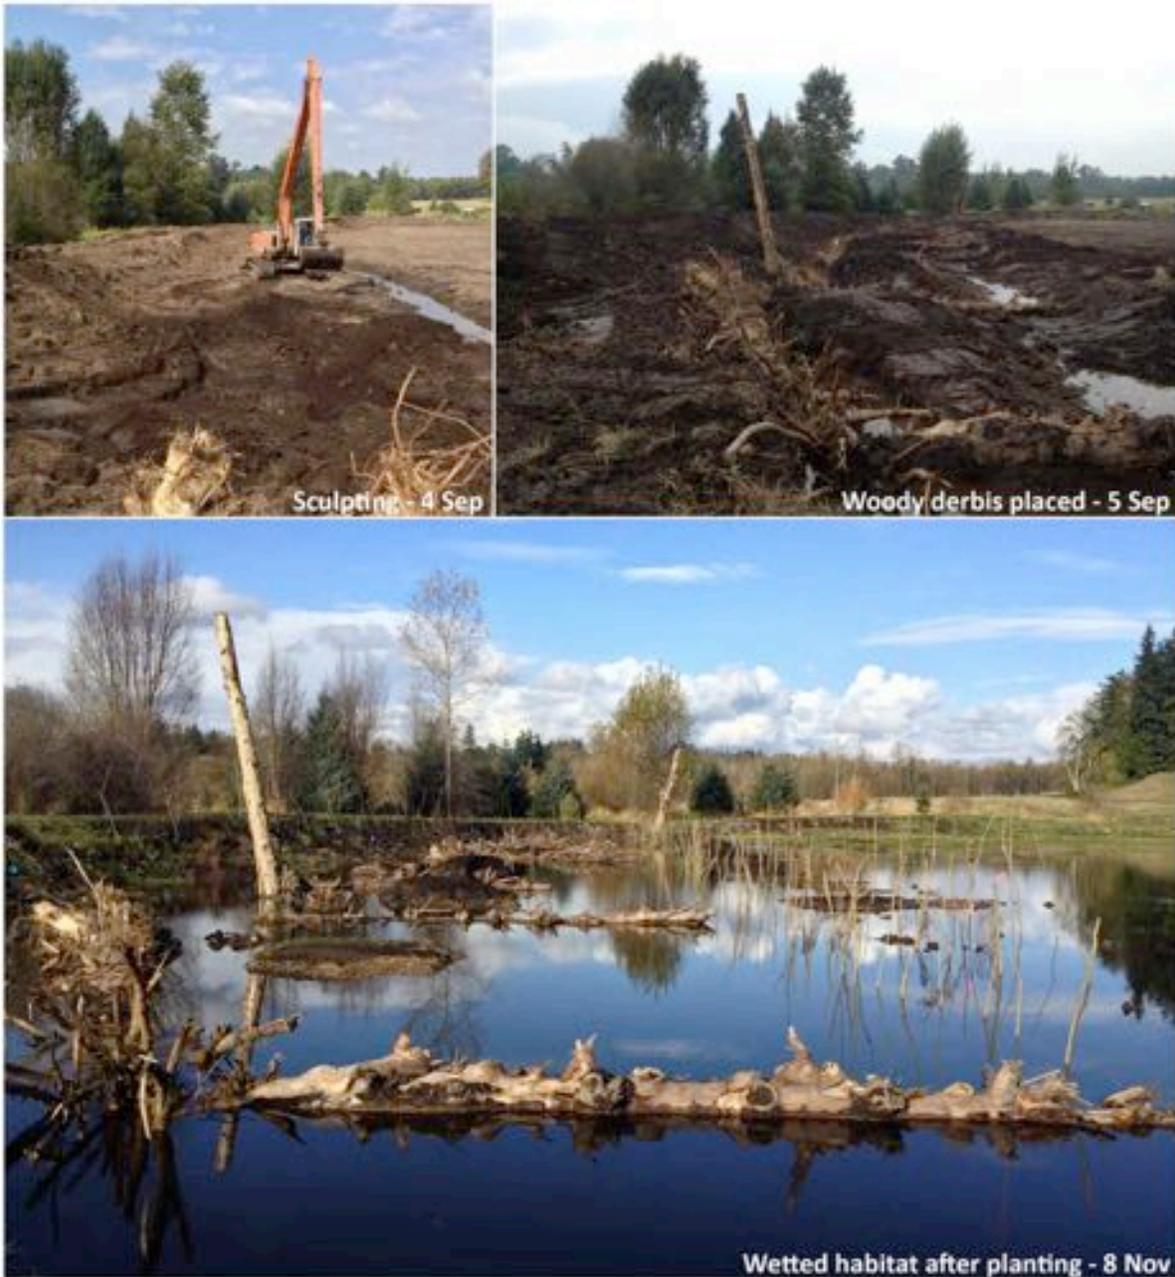
At the west edge of the south marsh is a 0.1 Ha low-water refuge with deep (> 1.5 m deep) channels broken up by islands and coarse woody debris. The woody debris provides refugia in times of low-water and increases complexity to reduce potential bullfrog densities.

Figure 7. Pre, during and post-construction of a complex, deep water refuge with access to permanent groundwater.

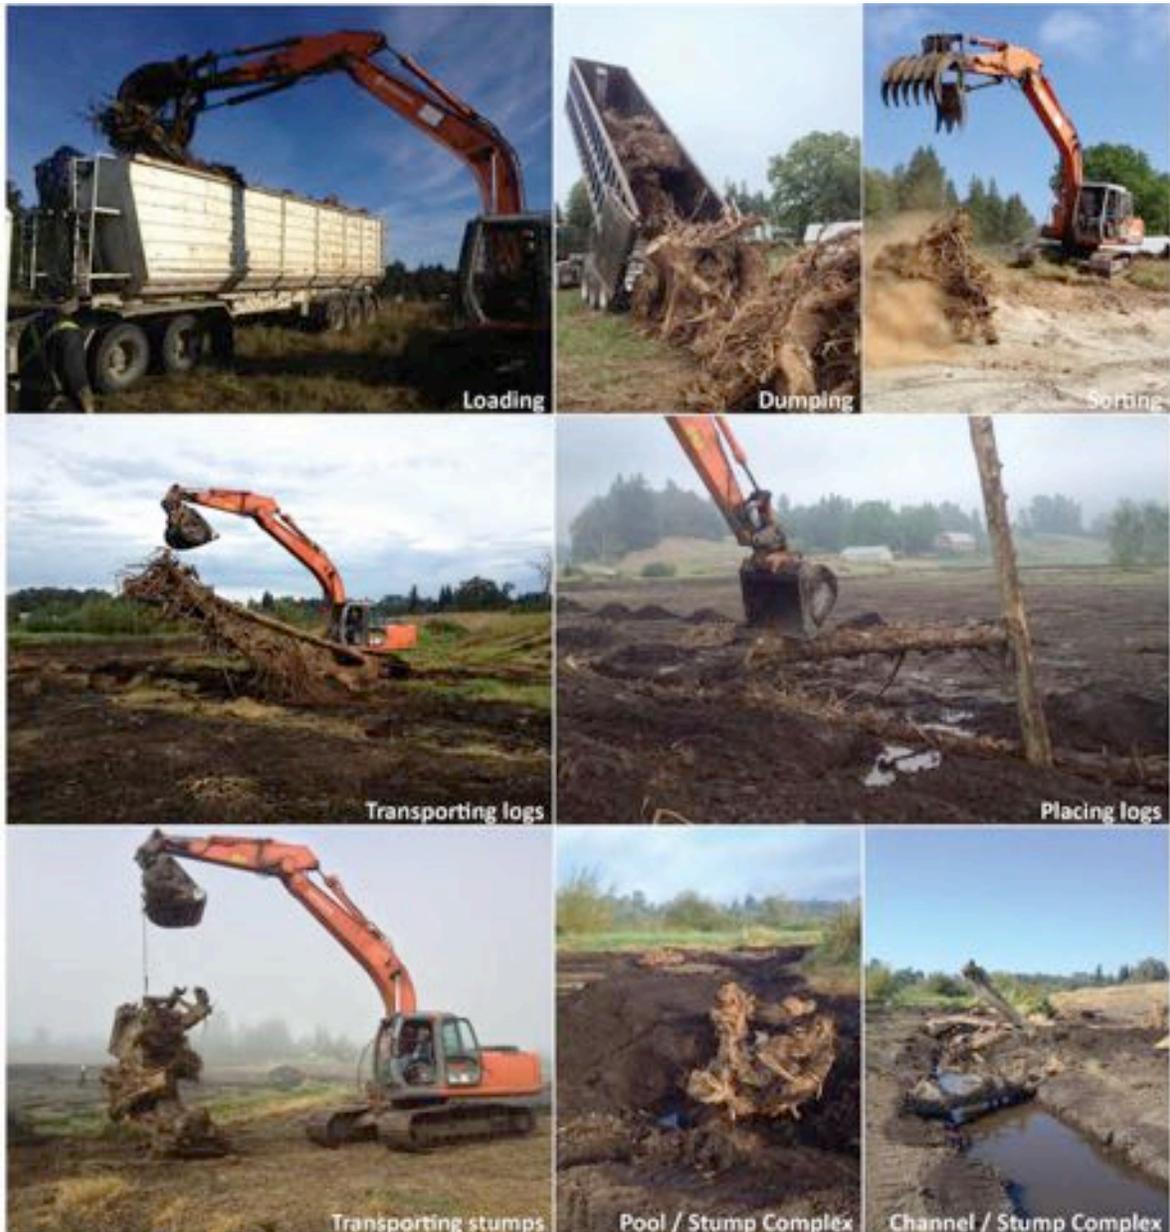
Coarse woody debris provides important nutrient cycling opportunities for fungi, bacteria and invertebrates that form the base of the food web, and also provides complex structures that serve as refugia for wildlife. Interactions between stable wood and moving water disrupt flows and increase chaos in the built environment. Coarse wood was incorporated primarily in deep habitats to provide water-wood interactions, refugia for wildlife, complexity to deep sites to reduce bullfrog densities, and to encourage invertebrate development.

Figure 8. Installation of coarse woody debris in the constructed marsh.

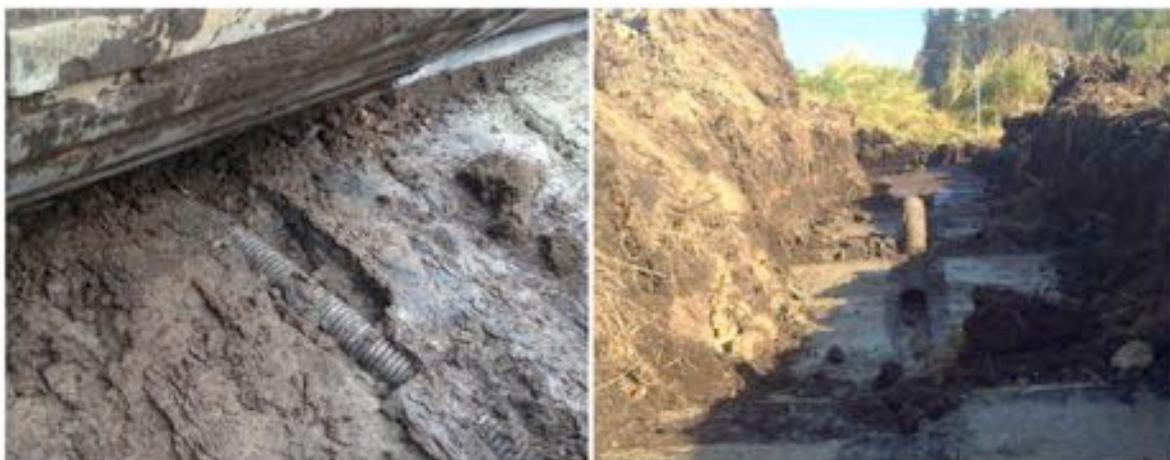
Hydrologic restoration required the removal of constructed drainage features (ditches, drain tiles) and reconnection to a permanent water source. One drainage channel in the south west meadow was filled and plugged at the south berm; a drainage channel at the base of the hill at the north end of the project was plugged to force water into the fields; one line of drain tile in the southwest field was identified and plugged with soil; and gravel weirs were constructed in the north and south berms for overflow. Gravel weirs were used in order to maintain a natural, low-impact aesthetic and to allow for easy modification.

*Figure 9. Drain tile uncovered and removed from east field.*

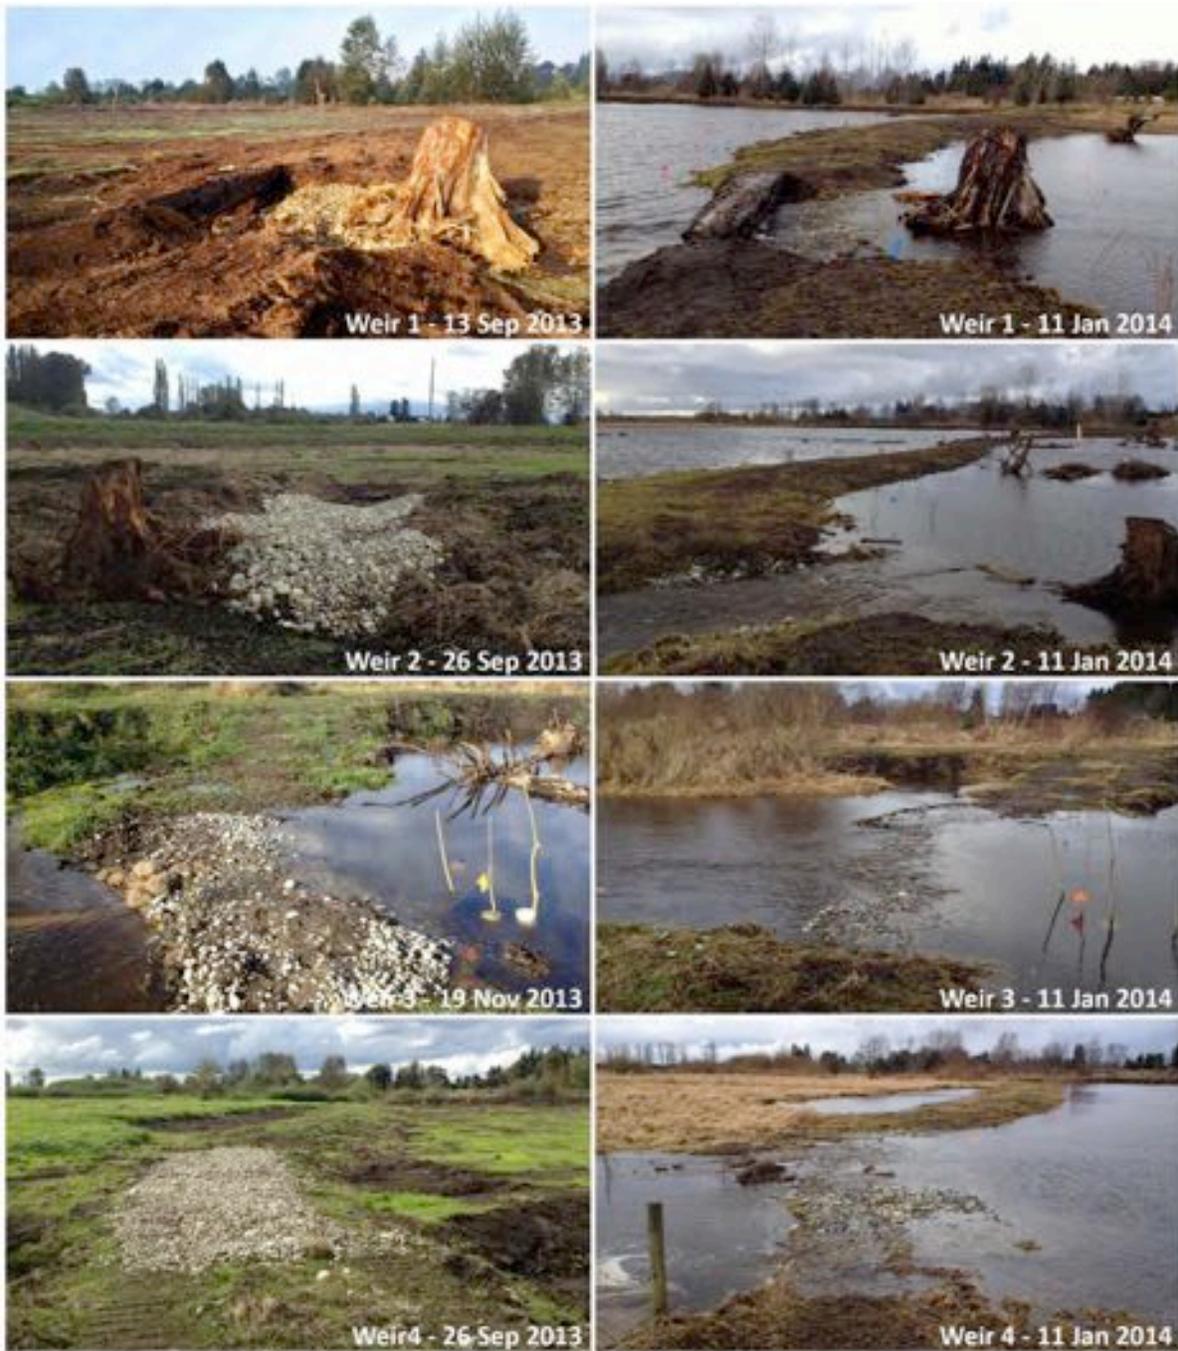
The south-west weir is permeated with a 25-cm PVC drainpipe that can be simply altered to drain the wetland to 30 cm below design elevation. Interchangeable PVC pipes are placed in an upright elbow at the upstream end of the drain to increase or gently reduce water levels.

*Figure 10. Gravel weirs / overflows directly after construction (Left) and directly following a large rain event (right). Weir elevations will be adjusted in 2014 to allow for settling of the disturbed grounds, and may be finalized after several years of monitoring. Weirs 1 and 2 drain the north pond into the marsh; Weir 3 drains from the south-west; Weir 4 drains south the central channel.*

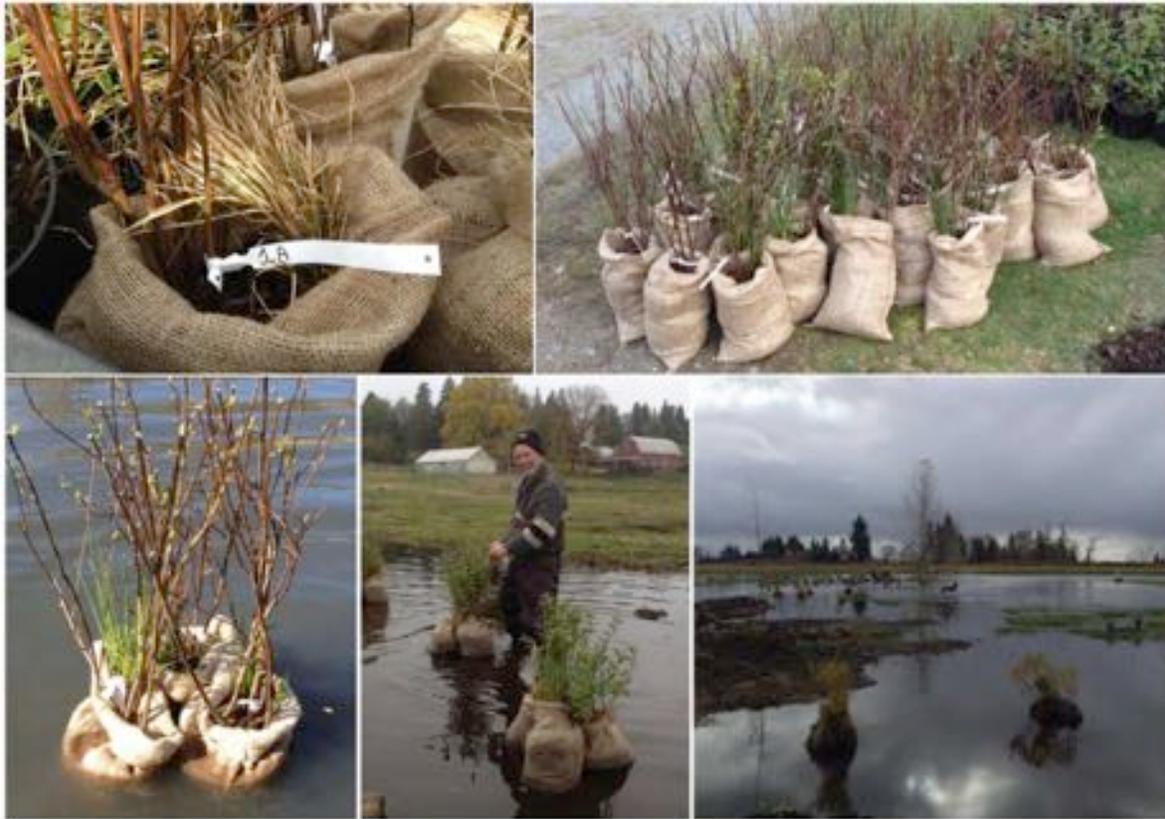
Hardhack-aquatic combinations were hardhack and aquatic herbs planted in the same pot, and combined to form hardhack ‘islands’. Each island was made up of a grouping (3-4 bags) of these combinations ‘planted’ in burlap sacks with a soil base, and staked around a wooden stake in the

wetland. These islands were placed in the deeper areas of the wetland to create living complex woody structures in the maturing wetland.

*Figure 11. Construction and placement of 'Hardhack combo islands'. Hardhack and aquatic plants are potted together in a burlap sack 1/3 full of soil. The sacks are placed in the wetland at depths of 20-30 cm to form 'islands' for multispecies habitat.*
