Construction Report: Gordon's Brook Phase III Adaptive Management

Submitted to:
Metro Vancouver Regional Parks
Environment and Climate Change Canada
BC Ministry of Forests, Lands and Natural Resource Operations
World Wildlife Fund Canada

By:
Natasha Wilbrink
Fraser Valley Conservancy
February 22, 2019

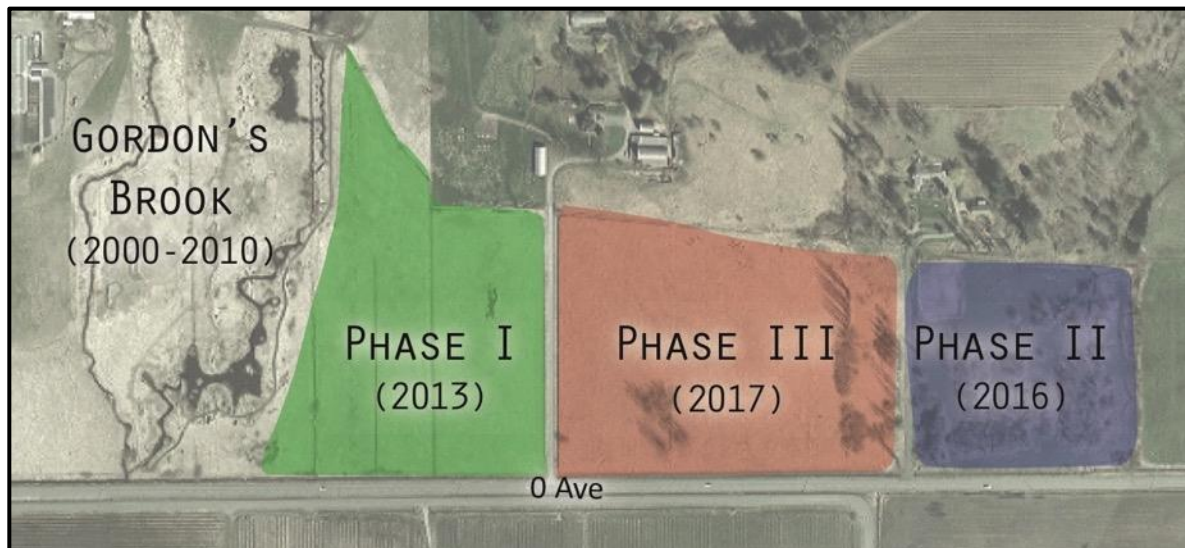
Figure 1: Site nomenclature for Gordon's Brook construction phases and original construction Pearson Ecological construction areas.

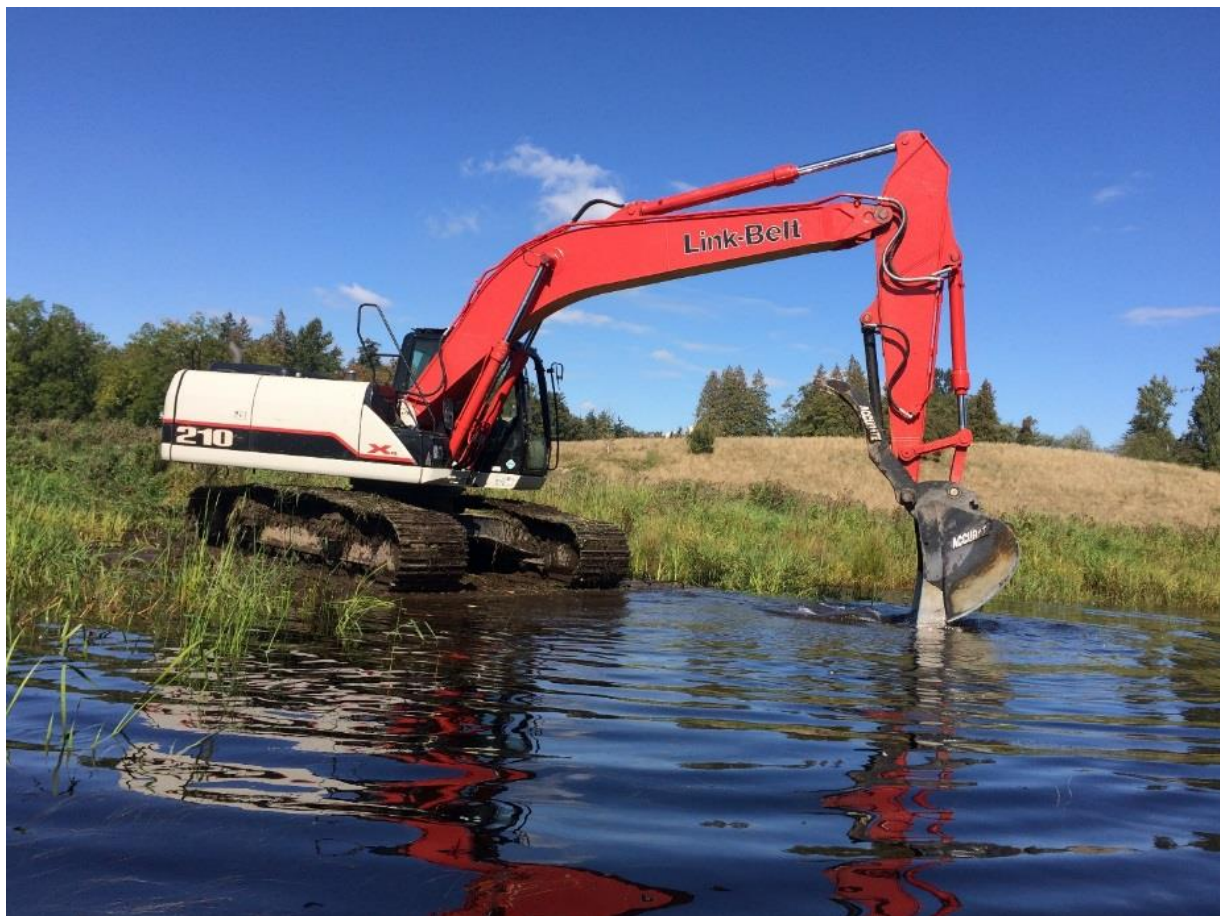
Figure 4: The majority of construction works were completed from swamp pads, while digging in the water.

Construction began September 18th on the east side of Phase III. Swamp pads were used throughout the site to allow access in high water level areas. Steps were taken to determine the necessity of silt screening by testing the disturbance created digging in the water. Turbidity increased slightly in immediate proximity to disturbance, but clarity remained consistent 1m from digging site. MTC operators were given a briefing on overall site plans and timelines. Specific details were given for each individual site as the machine moved between sites. A stop call was made whenever more clarification was needed.

PE and FVC staff utilized a canoe, surveying rod, and laser level to measure depth of the invert (the lowest point when looking at the cross-section of the ditch) of the 0 Avenue ditch and set a target depth for the wetlands. Throughout construction this method was used to locate the deepest portions of the wetlands and carve a channel at ditch invert level to the tie-in points (see Figure 4). Dams were built on the north and south sides of the tie-in points in order to allow bulk excavation of material in dry conditions. When the tie-in points were as deep as the ditch invert the dams were removed on the wetland side to allow water to inundate the tie-in point. This ensured sediment disturbance would be concentrated in the wetlands. After water settled dams were removed on the ditch side to establish a connection point. Spoil was integrated into existing berms and re-contoured.

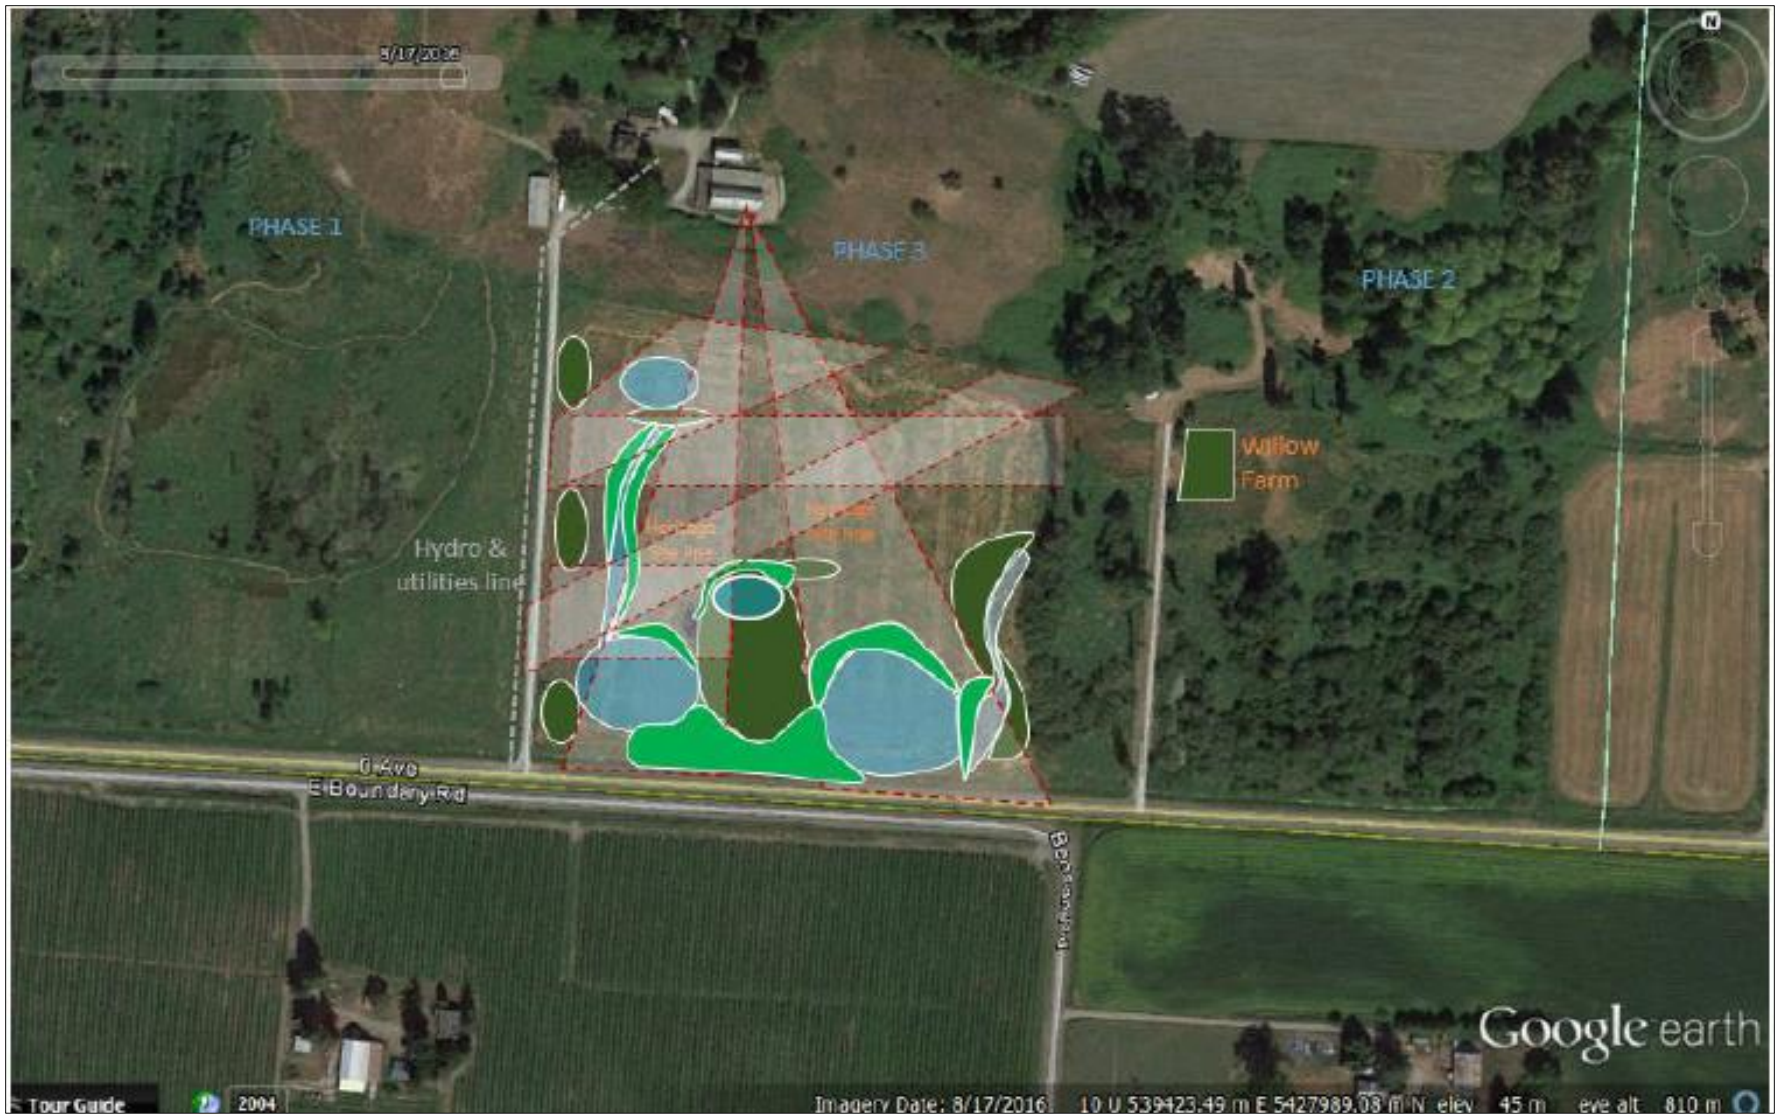
Figure 6: Sight lines to be maintained when planting as per Metro Vancouver Parks request.

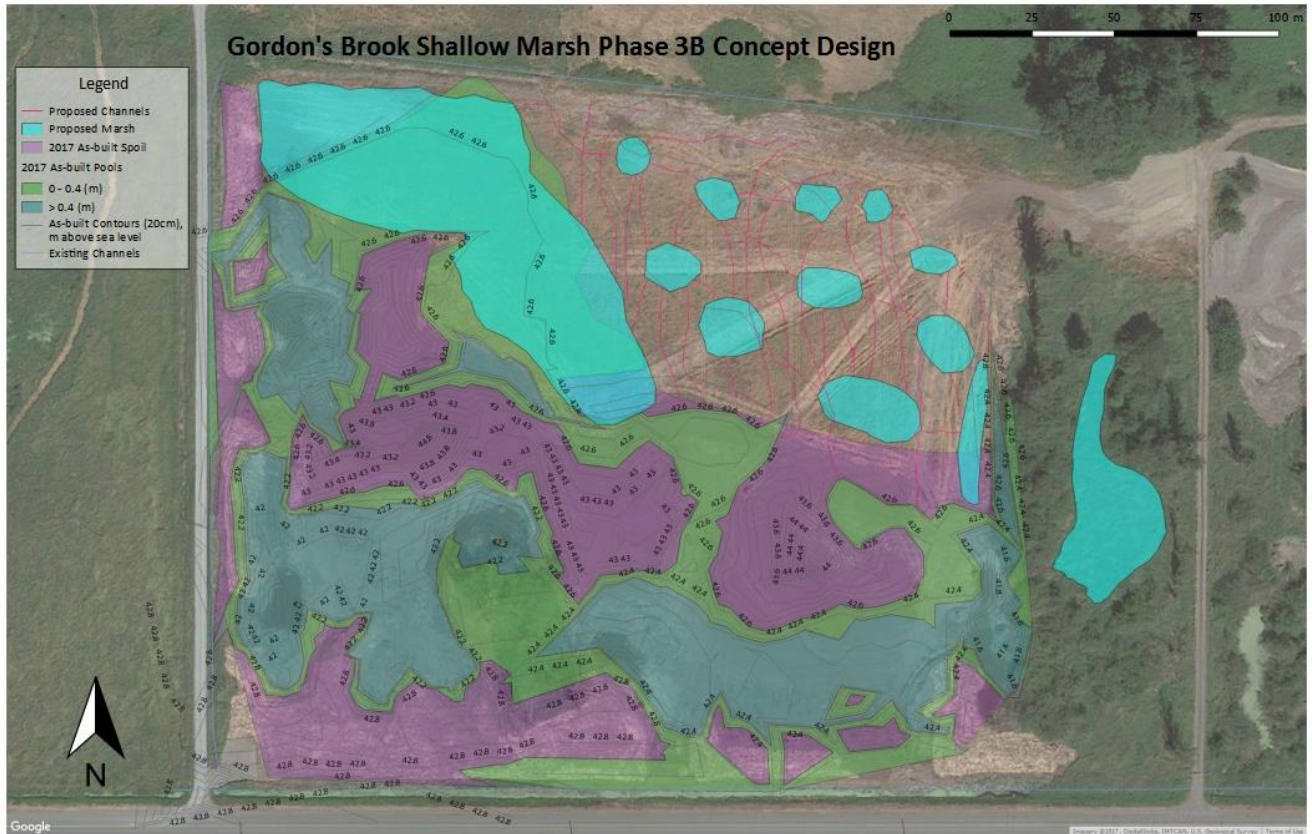
Figure 9: Concept design for Phase IIIB, complexing the north-east corner of the field and constructing additional ponds in the east sector.

The northern portion of Phase III provides the opportunity to continue restoration on this site. A concept design has been developed to take advantage of the floodplain within Phase III. It suggests additional complexing, creating a number of smaller pond wetlands with channels connecting the new ponds to

established portions of Phase III (see Figure 9). An additional shallow pond is proposed for the eastern section of Phase III targeting an area currently containing dead willows and open RCG areas. This project (Phase IIIB) would complement the deep-water refuge provided by the ponds in Phase III by providing shallower ponds targeting amphibian habitat. Inspiration for the design was obtained when examining historical photos of the Fraser Valley, particularly Sumas Lake (no longer present).
