# Management Plan Ryder Creek Property

1st Edition

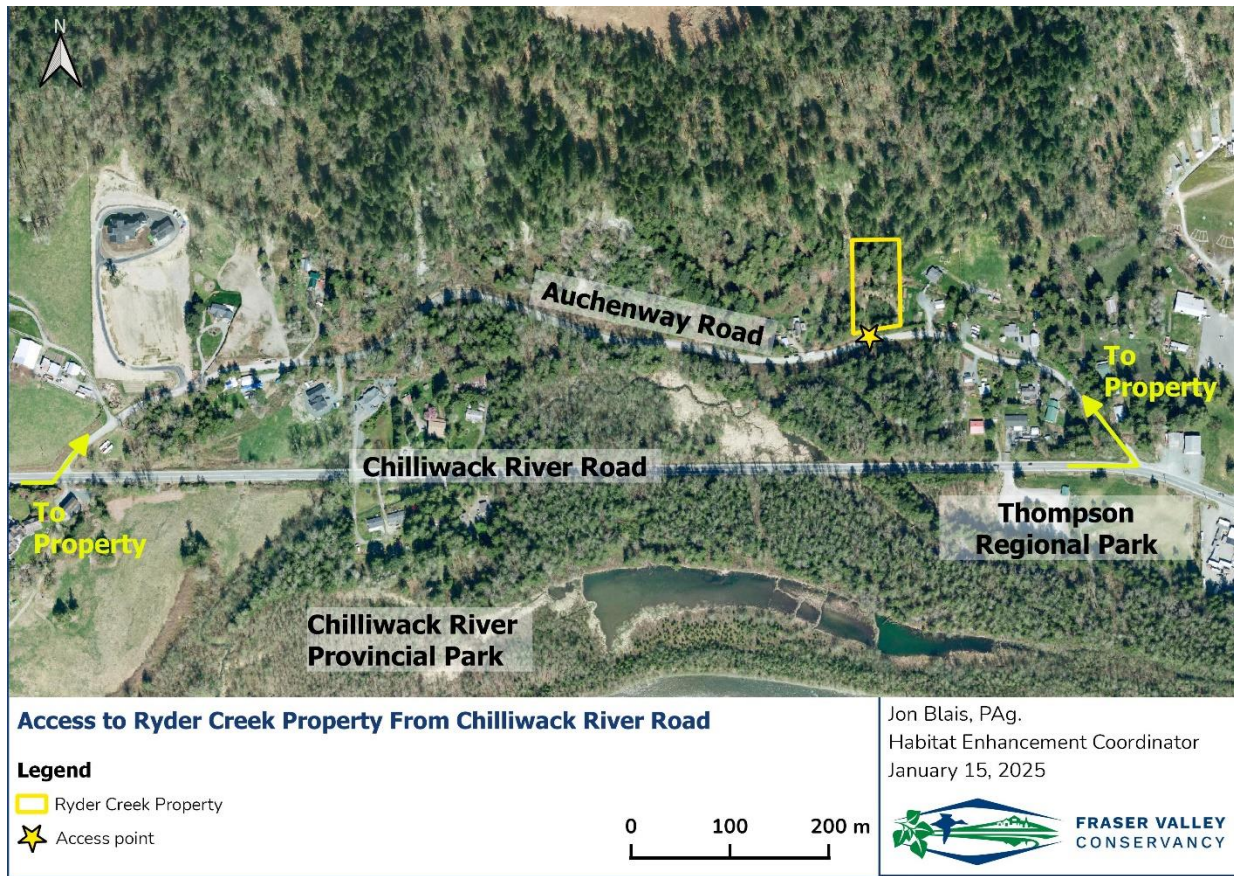
Figure 3 - Access routes to the property from Chilliwack River Road

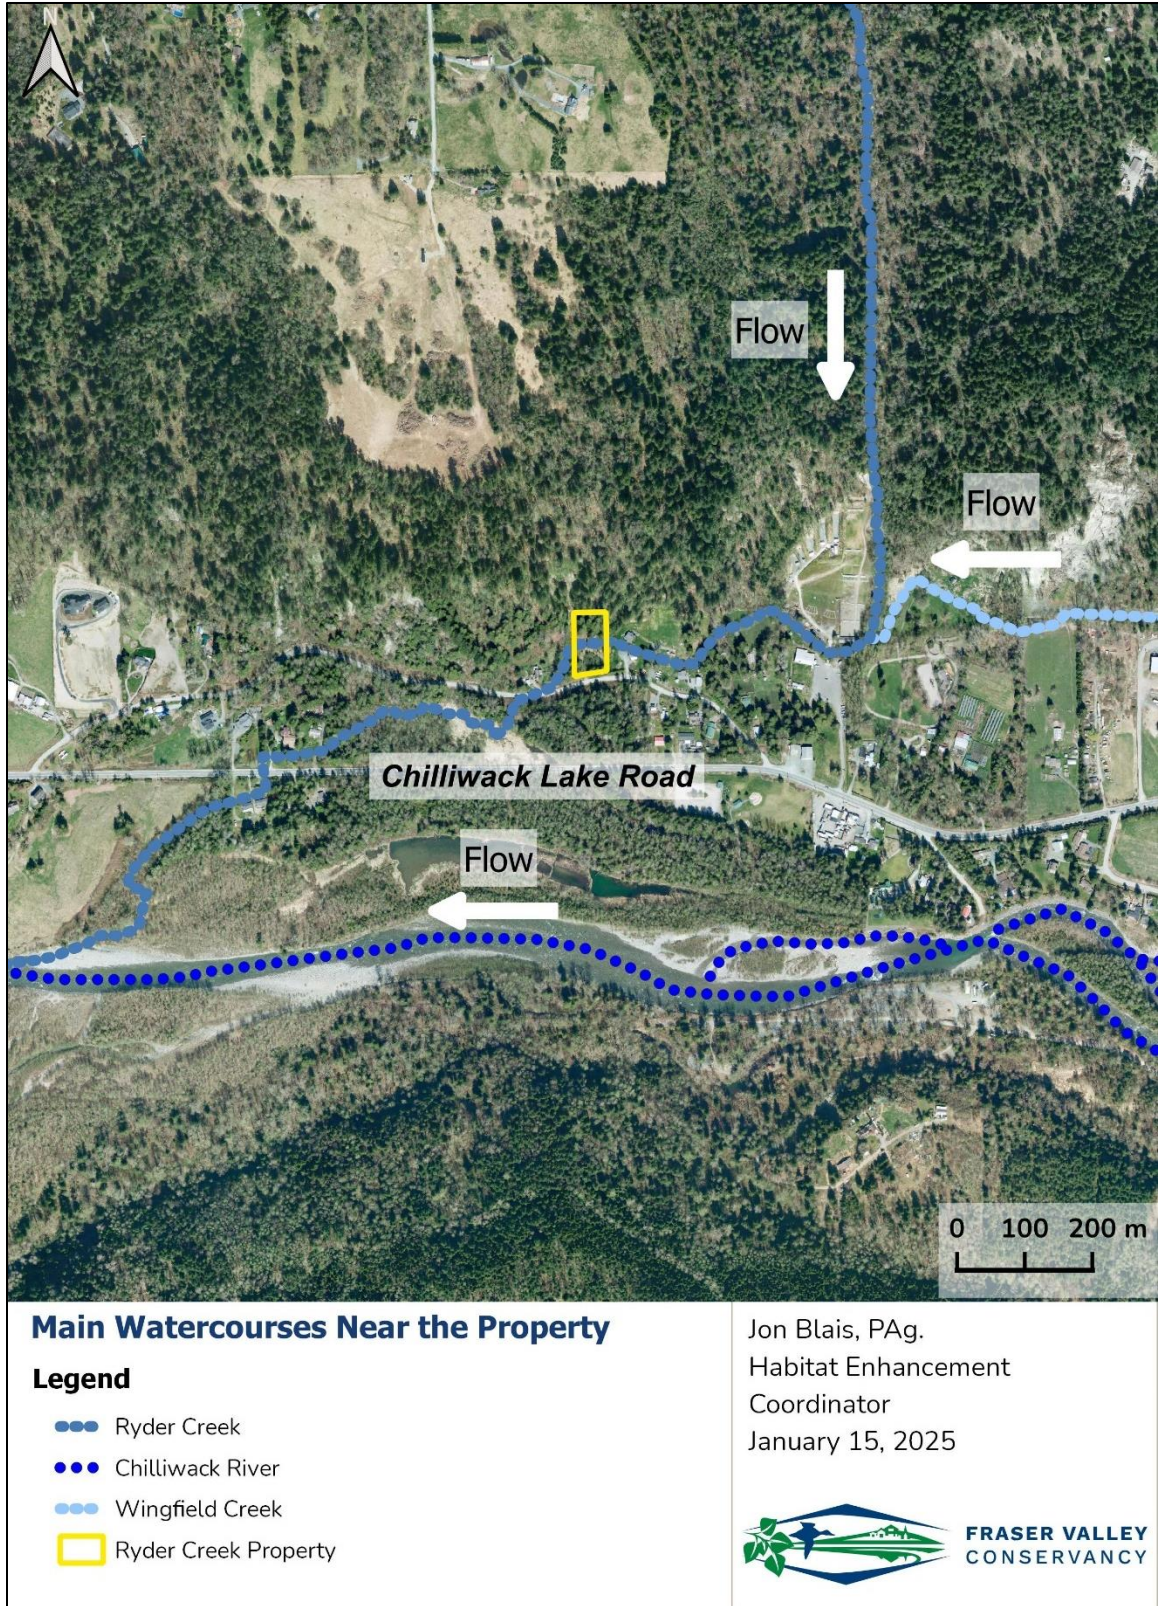
Figure 6- Watercourses connected to the property and surrounding area.

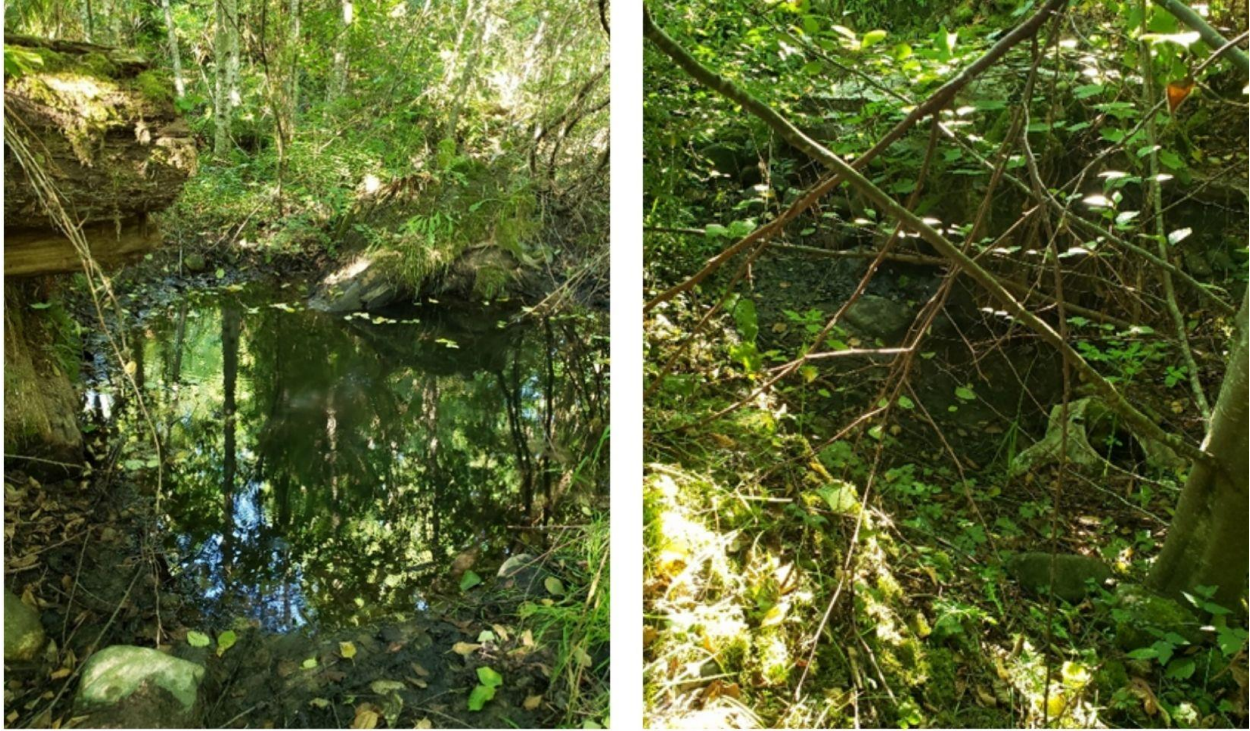
*Figure 7 - Photo of the permanent pond (left) and the ephemeral pond (right) taken on July 28, 2023.*
